**AN ECOLOGICAL ASSESSMENT OF THE HOLSLOOT RIVER,
WESTERN CAPE, SOUTH AFRICA**

submitted in accordance with the requirements for the degree of

MASTER OF SCIENCE

UNIVERSITY OF SOUTH AFRICA

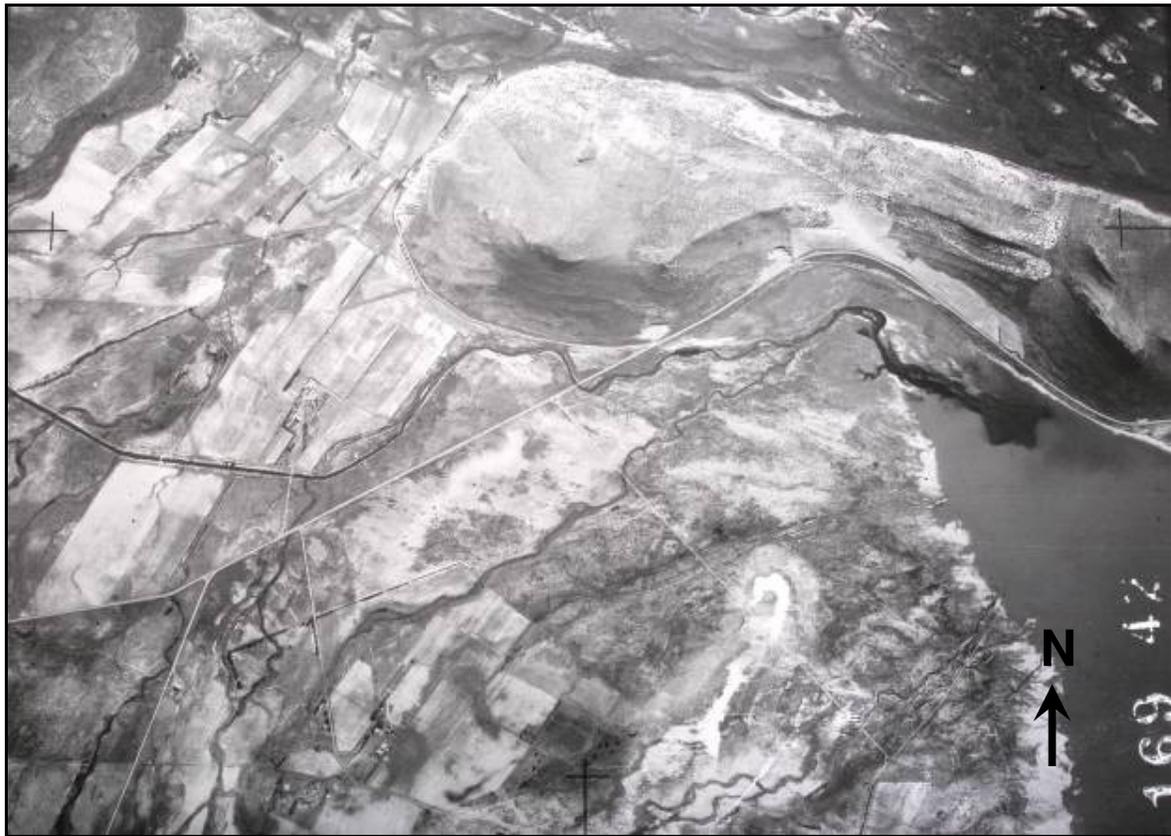
Figure 1: The western perimeter of Lake Marais (now the Brandvlei Dam) in 1942, with a braided system of streams flowing into the dam from the southwest (Department of Rural Development and Land Reform 1942).

Aerial photographs from 1942 (obtained from the Chief Directorate: National Geo-spatial Information) portray the Holsloot River as a braided system of rivulets, streams and wetlands (Figure 1). To facilitate the establishment of grapevines on the floodplain over the years, the river was increasingly canalised and the wetlands drained.

The Holsloot- and Smalblaar Rivers (tributaries of the Breede River) originate in the mountains to the south of Worcester. The lower reaches of these rivers historically flowed over the same floodplain in a northerly direction to the Breede River. The development of agriculture in later years caused the flow of these rivers to be transformed to such an extent that most of the runoff carried by the Holsloot was channelled into the first water storage facility in this area, Lake Marais. Lake Marais (now known as the Brandvlei Dam), was constructed in 1922 to meet the increased demand for irrigation water in the dry summer months (Figure 1; DWAF 1995).

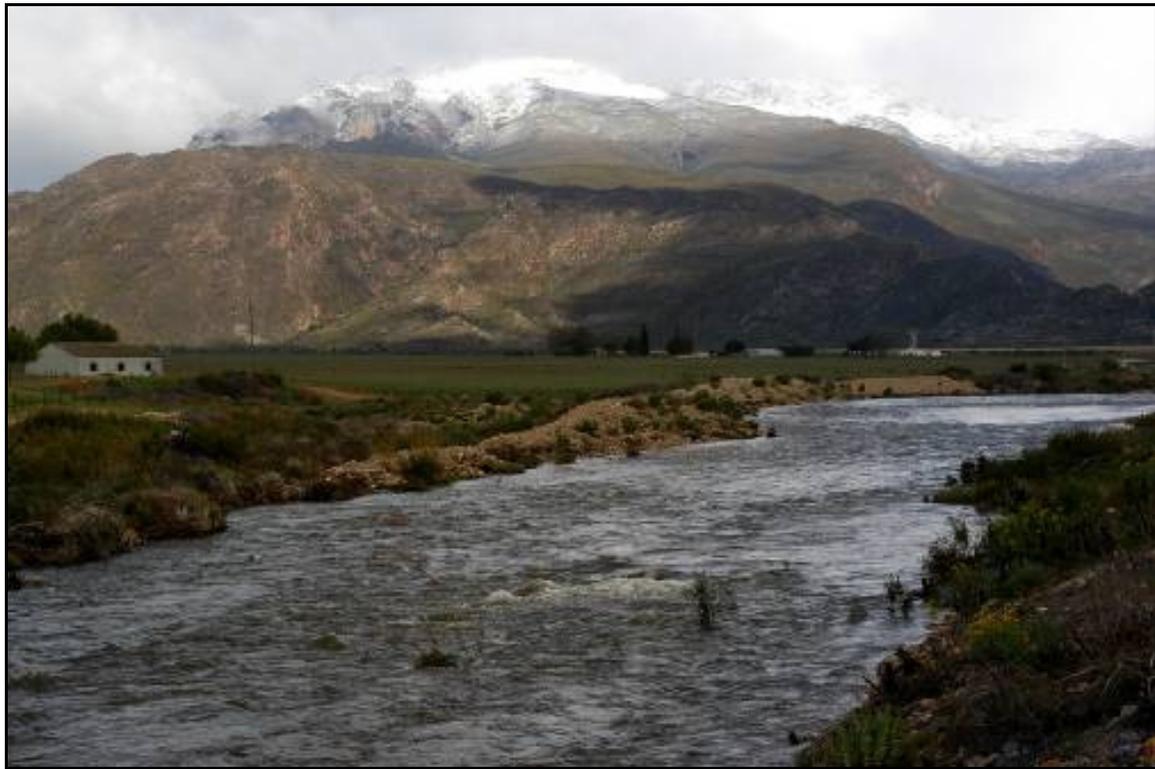
Figure 3: The lower reaches of the Holsloot River; after heavy rains and snow in August 2008.

The Holsloot River, a tributary of the Breede River, drains areas of the Du Toit's Mountains, Wemmershoek Mountains, Stettyns Mountains, Kweekkraal Mountains, Wabooms Mountains and Brandvlei Mountain (Figure 2). Together with other mountains drained by the upper Breede River (Witteberg Mountains, Klein Drakenstein Mountains, Limietberg Mountains and Slanghoek Mountains), these mountains are part of what is known as the Cape Syntaxis, where the western and the southern branches of the Cape Fold Mountain Belt meet (Gresse & Theron 1992). This part of the upper Breede River catchment-area lies in the Western Folded Mountains Eco-region, southwest of the town of Worcester in the Western Cape Province of South Africa (Figures 2 & 3; Table 1).

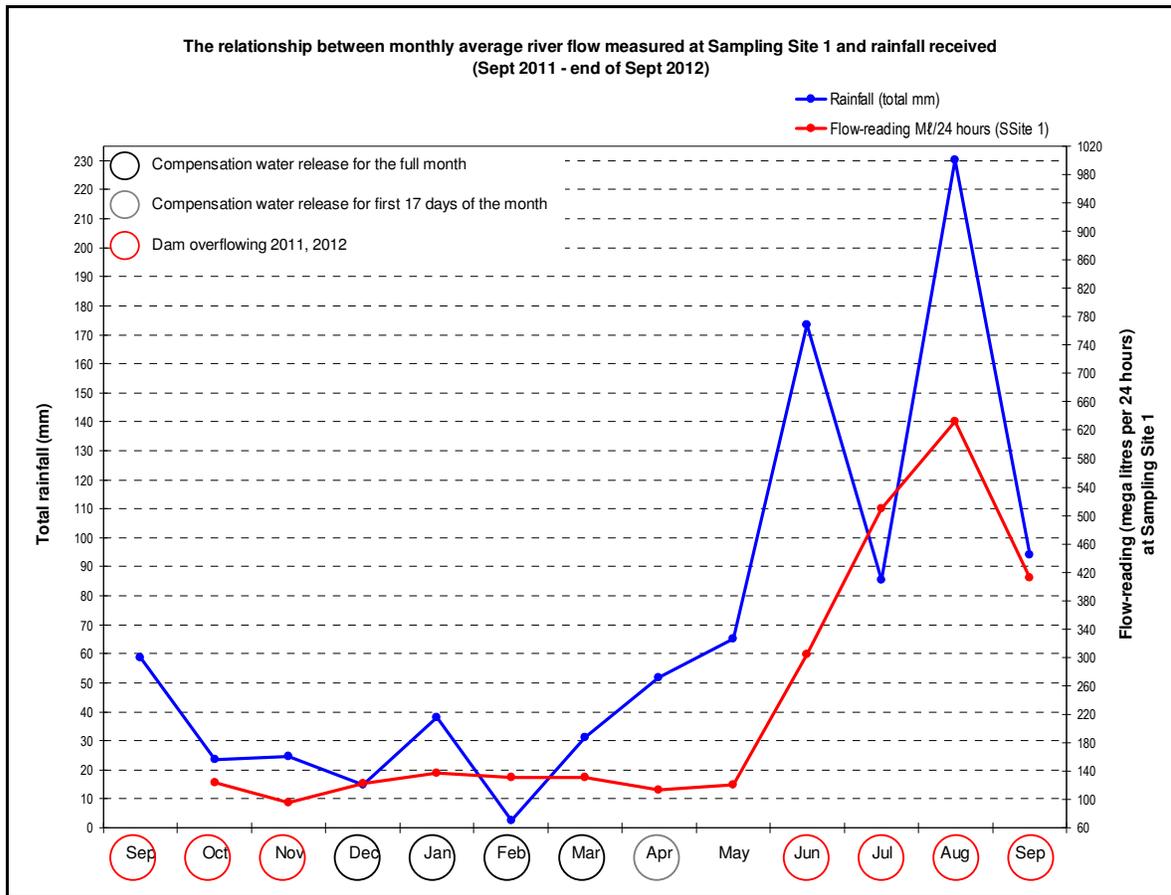
Figure 7: The association between monthly average stream flow and the total rainfall received during the period between September 2011 and the end of September 2012 (Sampling Site 1).

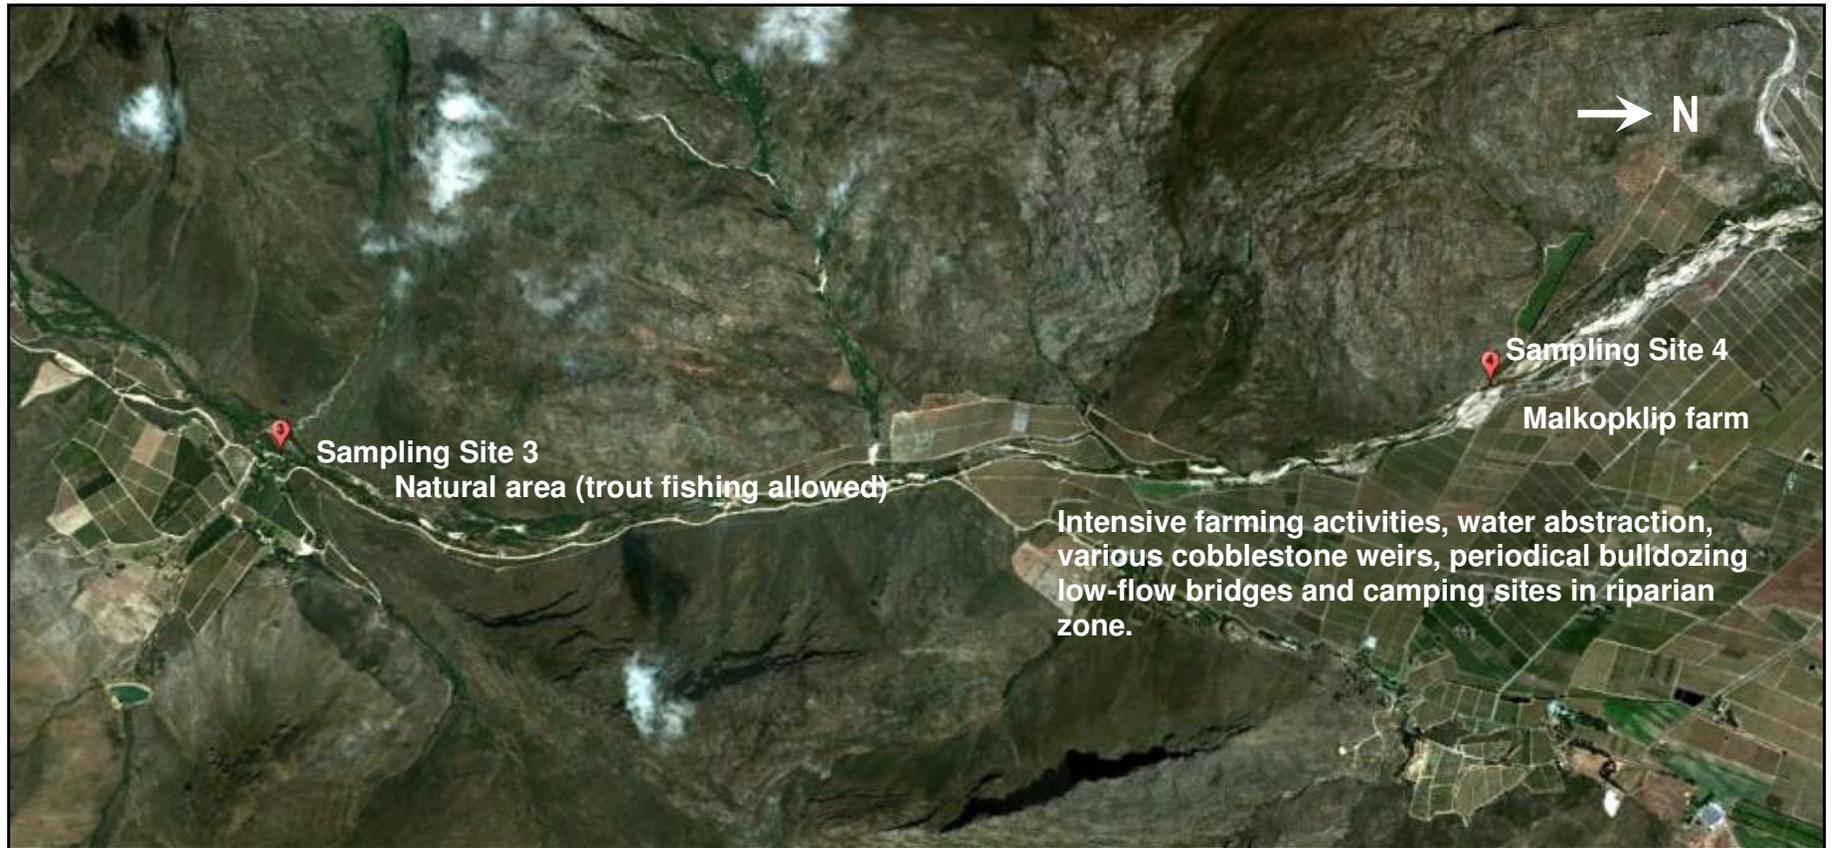
Figure 17: Apart from the natural area just downstream from the farm Dwarsberg, land-use between the Dwarsberg and Malkopklip farms involves intensive farming activities as well as recreational use of the river (from the Google Earth Satellite Image 2012).

Because of the farming activities upstream as well as at Sampling Site 4 (Figure 17), EC was expected to be higher than that of the Reference Site. The dissolved salt concentration at Sampling Site 4 was however found to be lower than that of the

Although alien vegetation infestation (mainly *Acacia mearnsii* and *Sesbania punicea*) is a problem in this area, the river flows through a fairly natural area between Sampling Sites 3 & 4 (Figure 17).

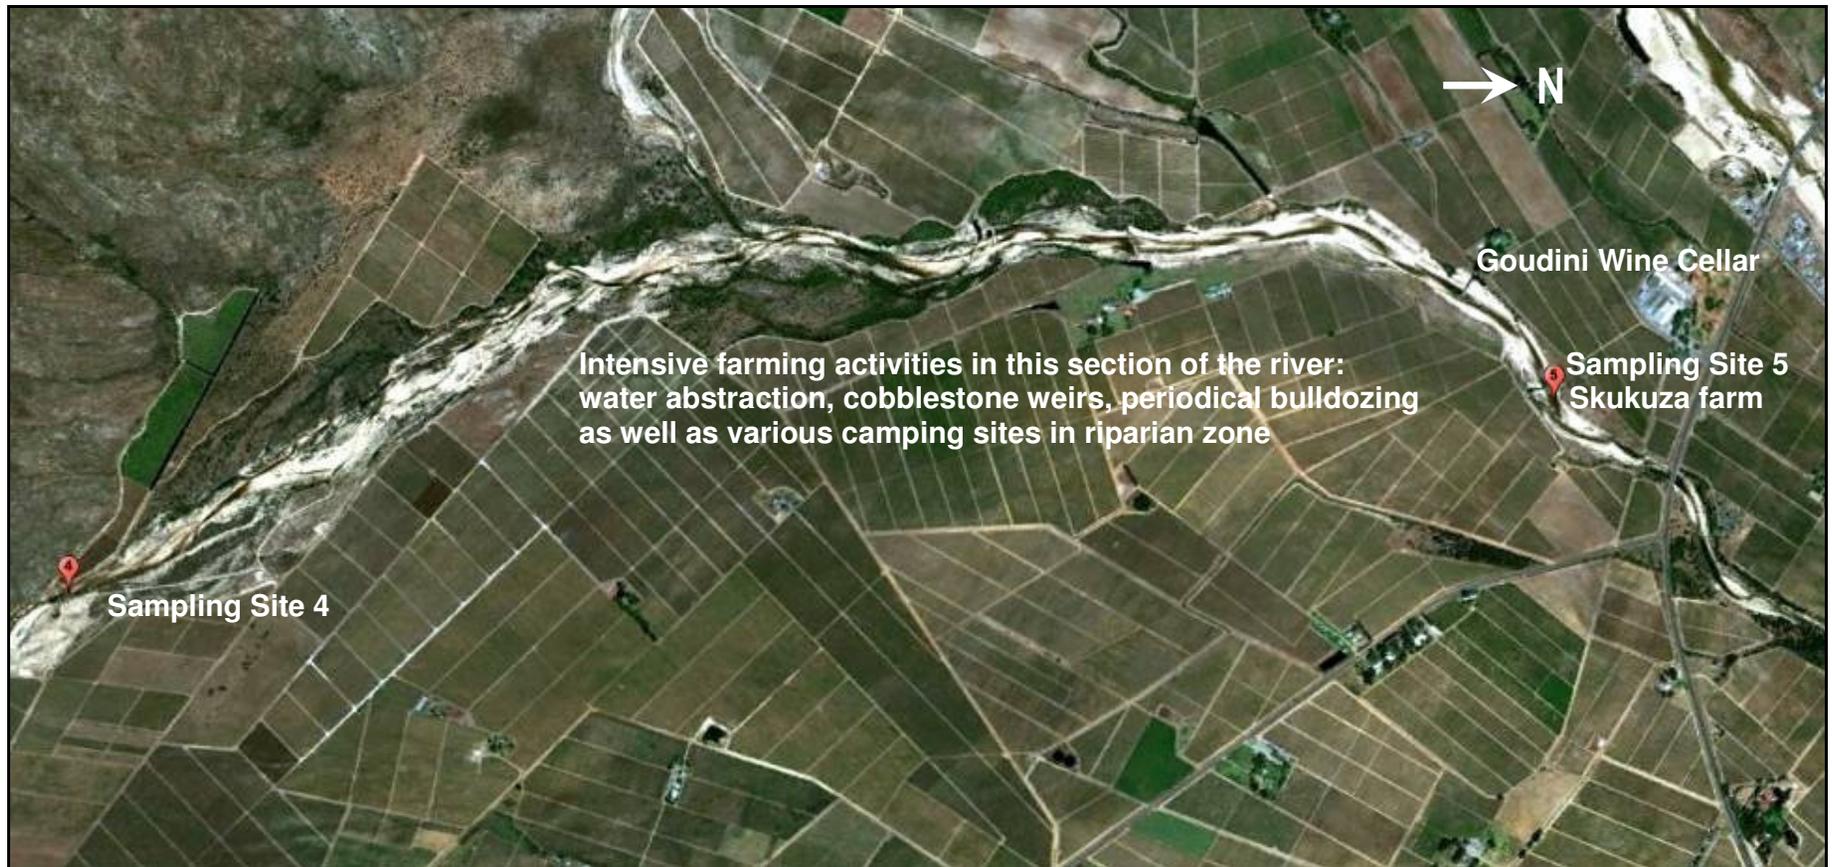
Figure 18: Land-use between the farms Malkopklip and Skukuza comprises of intensive farming activities as well as recreational use of the river (from the Google Earth Satellite Image 2012).

The surroundings of Sampling Site 4, in the middle reaches of the Holsloot River, marks the start of intensive farming activities as the valley expands from here northwards towards the Breede River (Figure 12 & 18). Where the river historically divided into a braided network of streams, and where vineyards were established in various areas between the streams (as depicted in Figure 19), the middle reaches of the river is completely covered in vineyards today and the river canalised to a single stream at the foot of the mountains to the west (Figure 18).

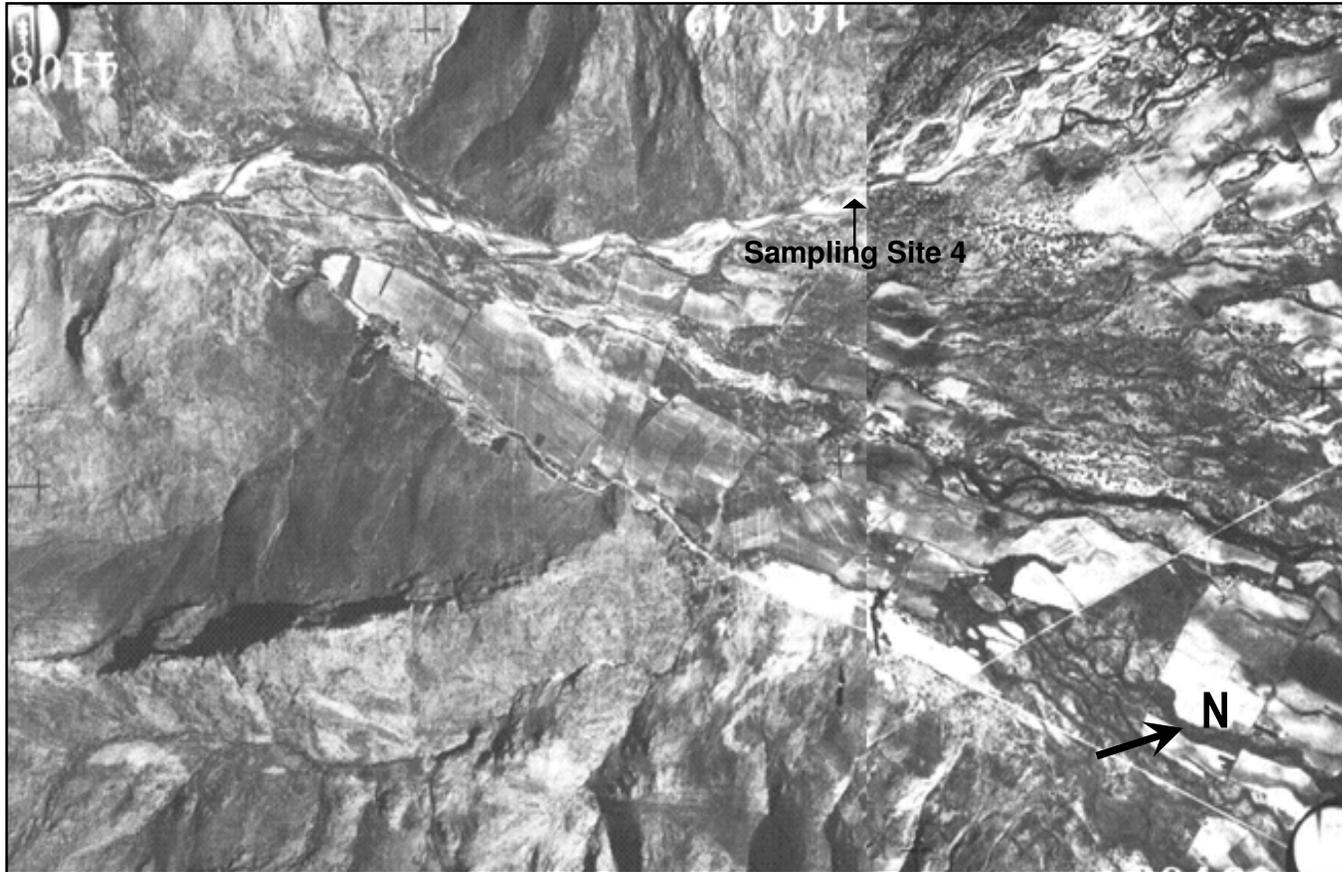
Figure 19: An assemblage of aerial photographs from 1942 indicates the braided stream character of the river in the middle reaches, as well as the extent of agricultural development upstream and downstream of Sampling Site 4 (Department of Rural Development and Land Reform 1942).

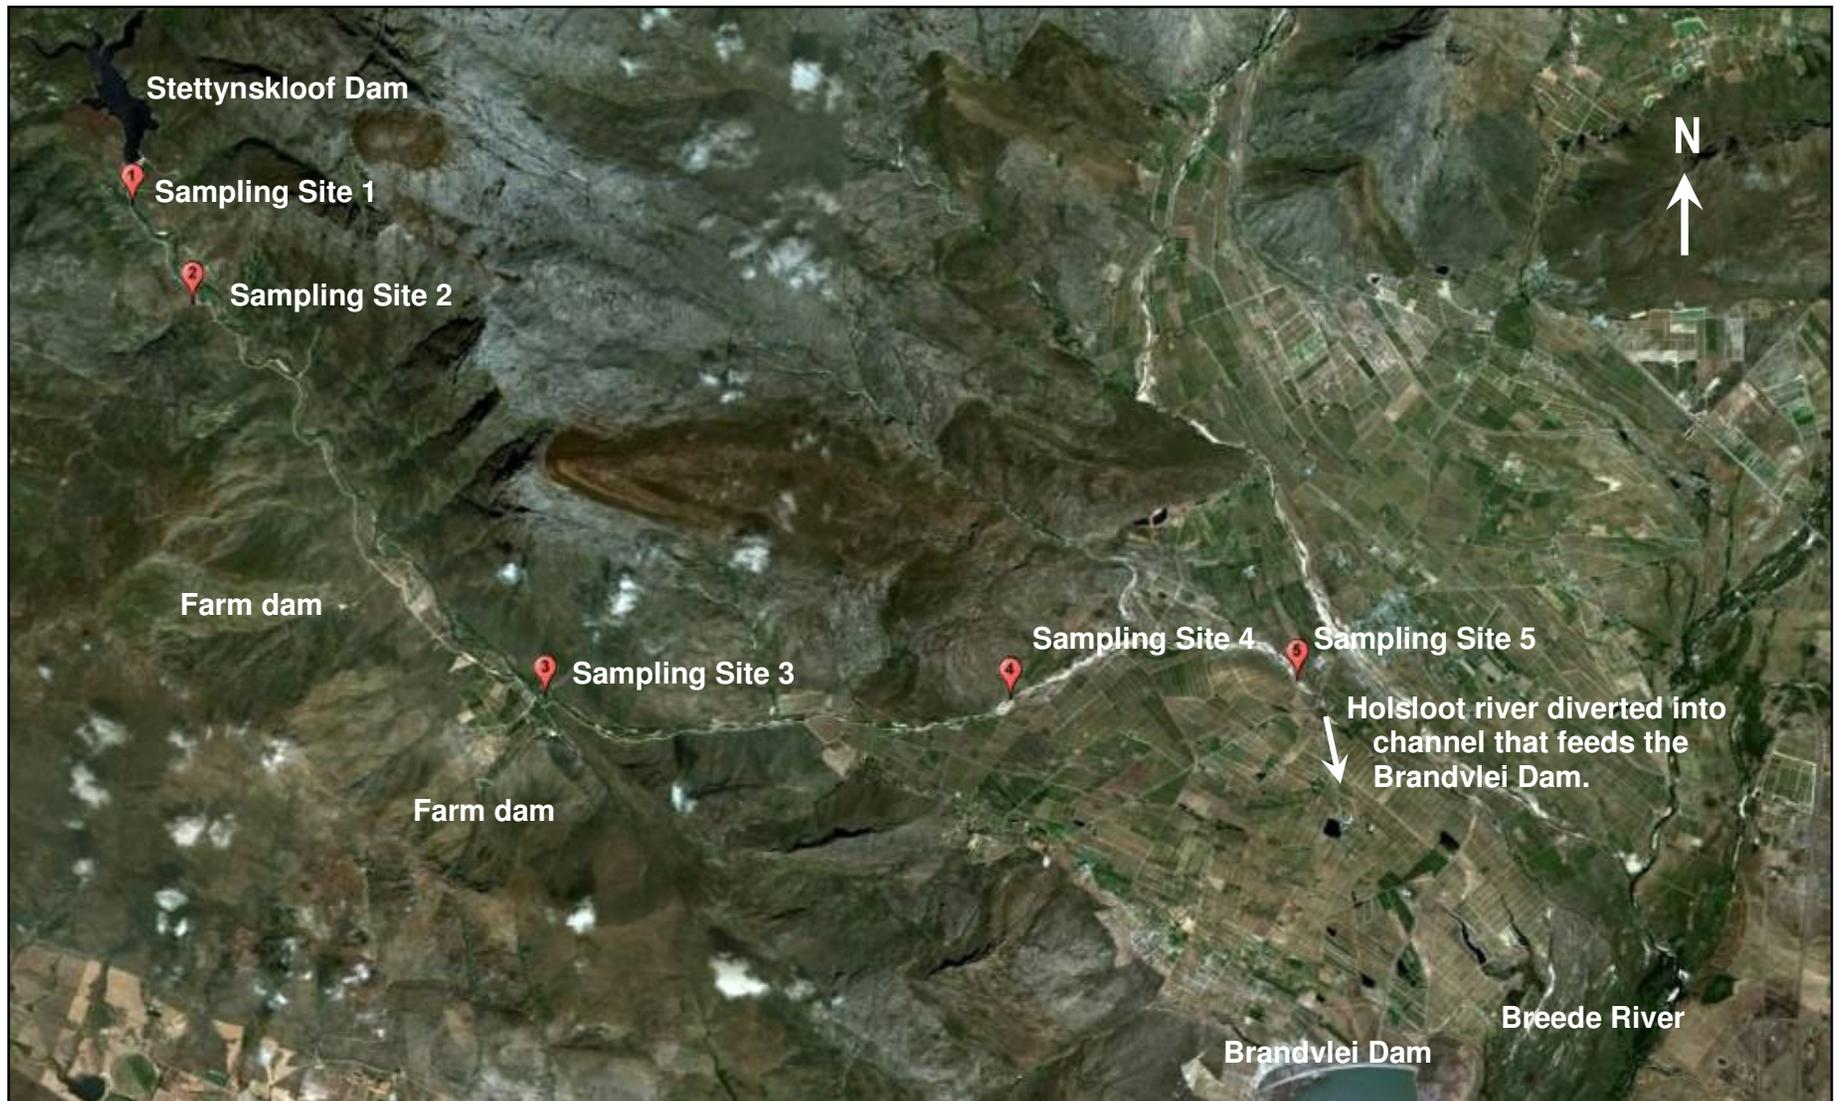
Figure 20: Land-use from the Stettynskloof dam to where the Holsloot River joins the Breede River northeast of Sampling Site 5 (from the Google Earth Satellite Image 2012).

Maps, aerial photographs as well as *Google Earth* satellite images were used to identify possible sample sites. Various site visits were then undertaken during July and August 2008 to assess potential impacts and identify suitable sampling sites. Five sample sites were selected (Figure 20) and are indicated in Figures 21-30.

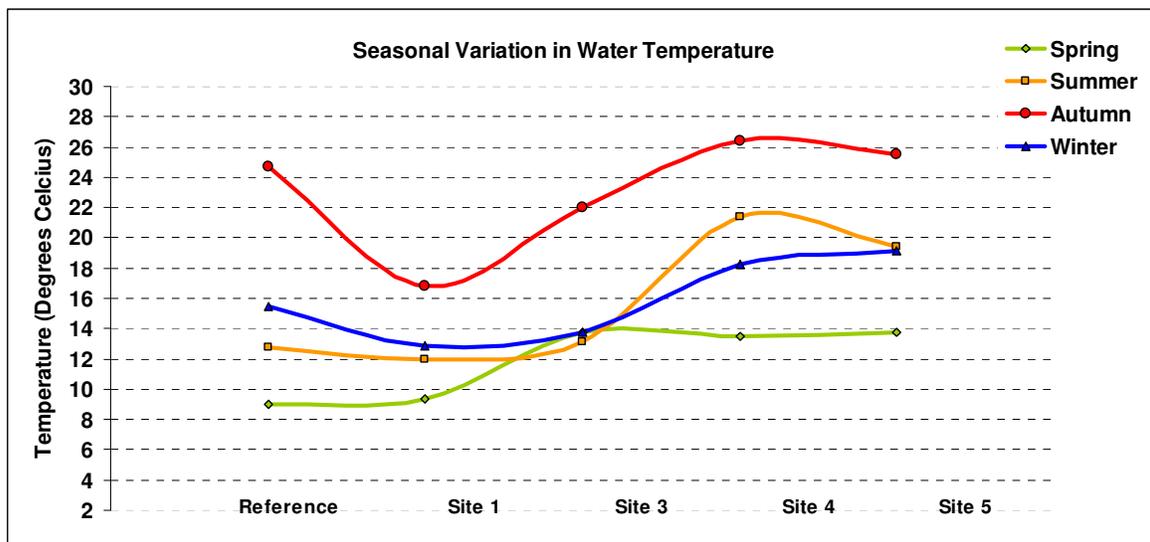
Figure 33: Seasonal variation in water temperature (2011 – 2012).

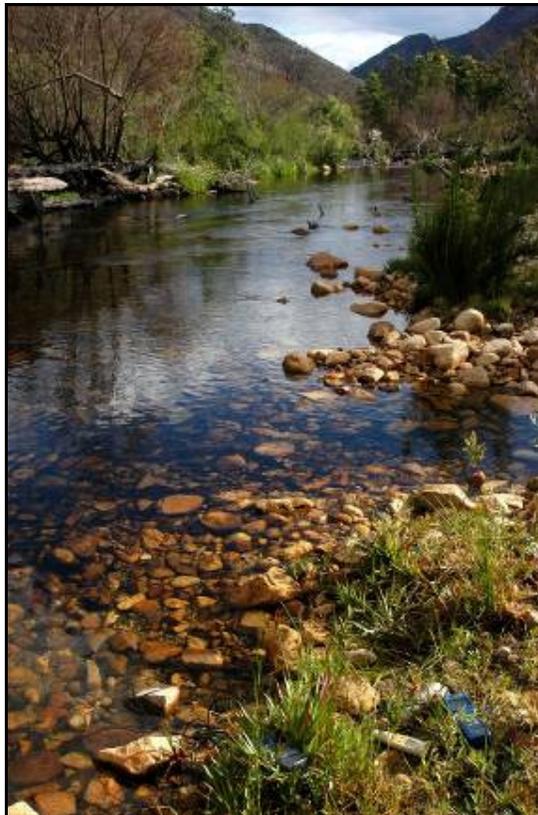
Figure 36: The water level - Sampling Site 3
in summer – most cobblestones
are submerged.

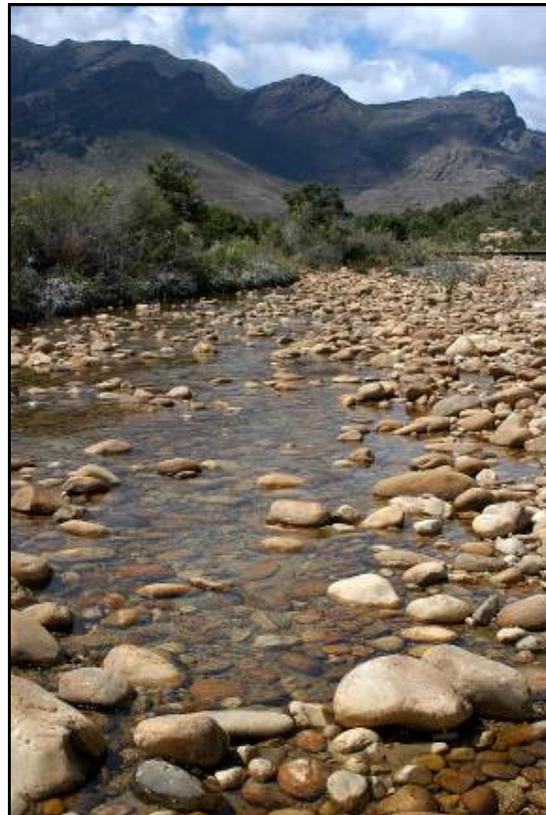
Figure 37: A lower water level - Sampling
Site 4 in summer: many
cobblestones are not submerged.

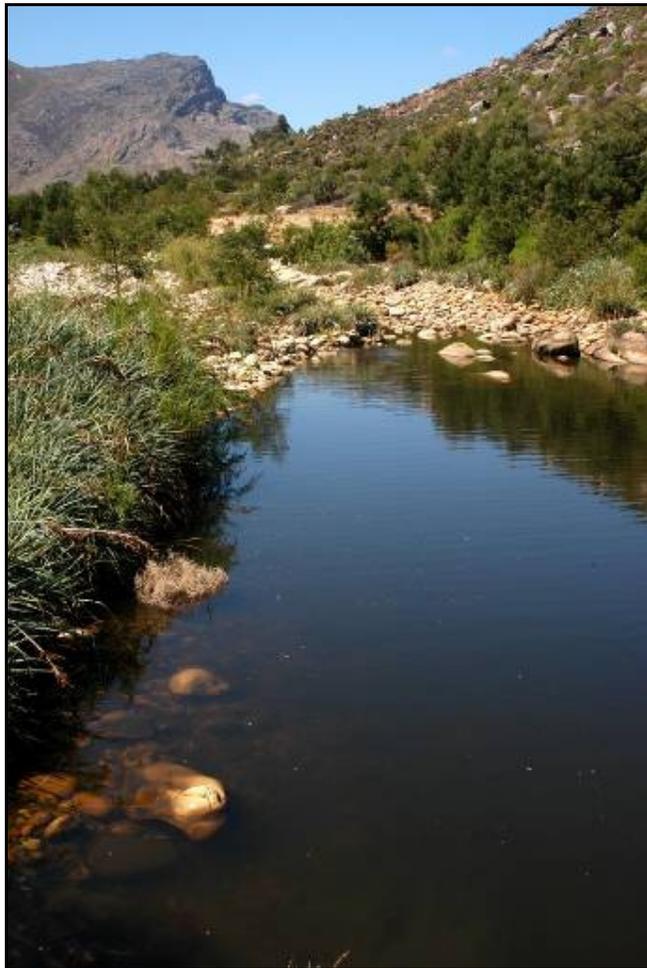
Figure 38: Water dammed during low flow conditions at an abstraction point at Sampling Site 4 in autumn.

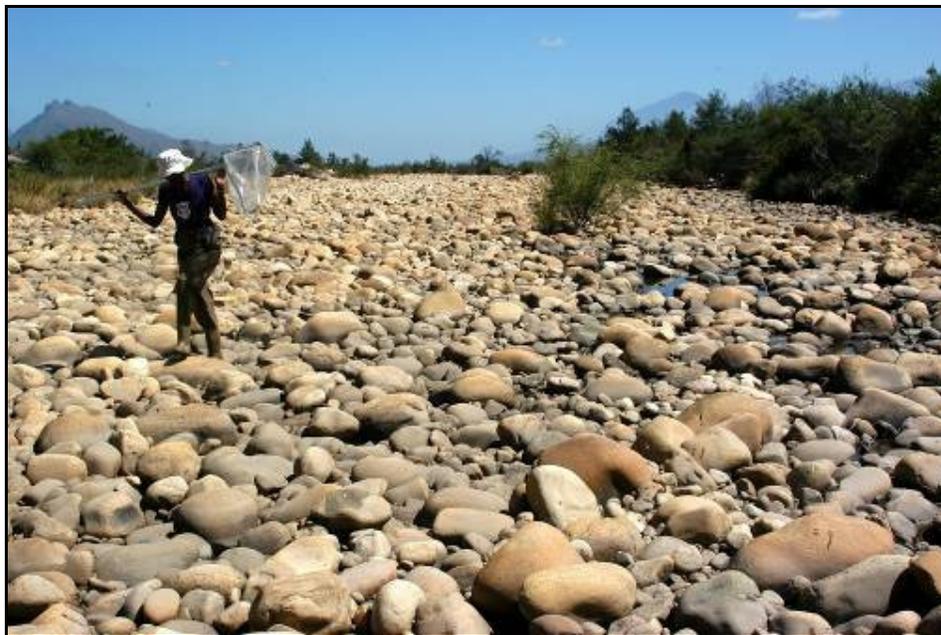
Figure 39: Low flow conditions at Sampling Site 4 in autumn – surface water is known to disappear at this point during the dry season.

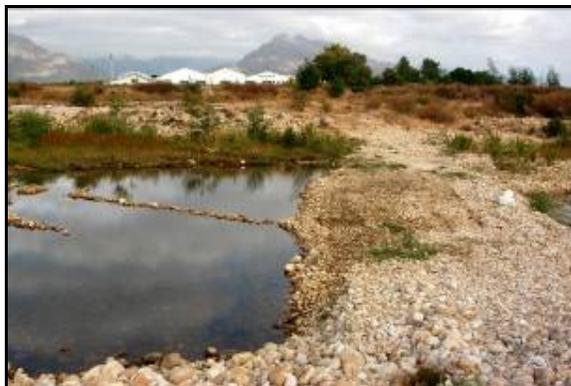
Figure 40: Damming for water abstraction at Sampling Site 5, autumn 2012.

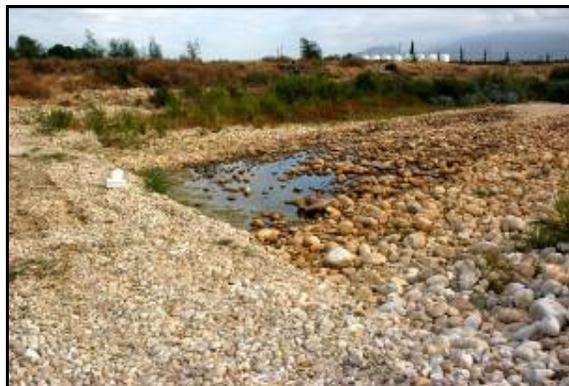
Figure 41: Low water level and flow at Sampling Site 5 in autumn 2012.

An elevated low-water bridge at Sampling Site 4 has fewer effects on the stream than the practice of bulldozing a road across the river as done at Sampling Site 5 in the dry season (Figures 40 & 41; Table 11). The road obstructs surface flow and causes shallow standing water on both sides thereof. Evaporation enhanced by strong winds in the dry season can cause concentration of dissolved compounds. Seasonal bulldozing has destroyed the riparian vegetation to only a fringe at the edge of the water in some places.

According to the IHAS percentage score, Sampling Site 5 is *highly suited for supporting a diverse aquatic macro-invertebrate* community at times of moderate water levels during summer (Figures 29 & 30) and winter. The high level of inundation during spring rendered the site *adequate for supporting a diverse aquatic macro-invertebrate community* (Figure 57). Low water level in autumn, together with flow-obstruction created by the bulldozing of a road through the riverbed caused the site to be *inadequate for supporting a diverse aquatic macro-invertebrate community* in autumn. (Figures 40 – 41; Table 17).

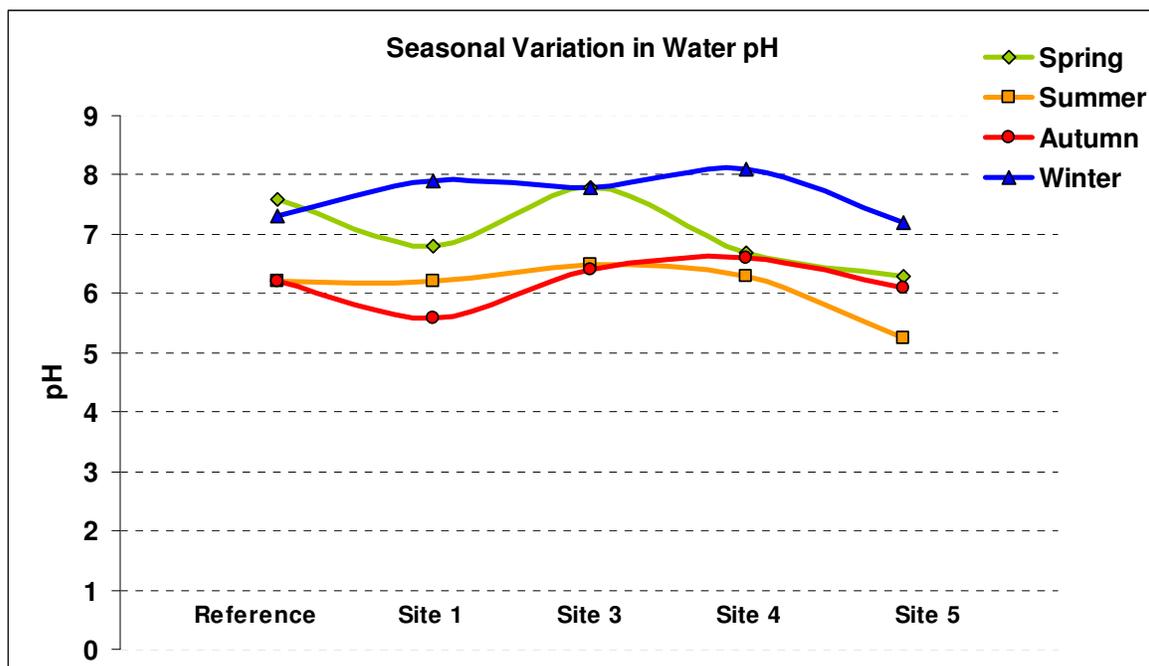
Figure 42: Seasonal variation in water pH (2011 – 2012).

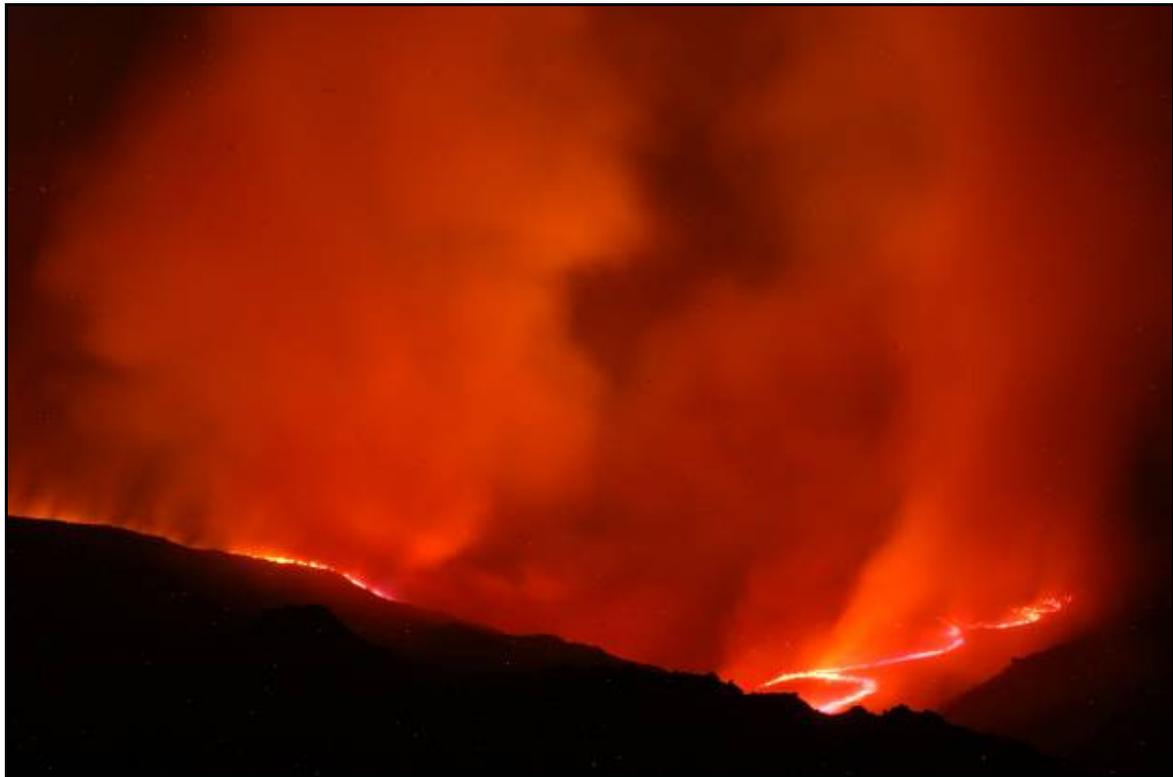
Figure 43: An uncontrolled fire raging through the Stettynskloof in January 2011.

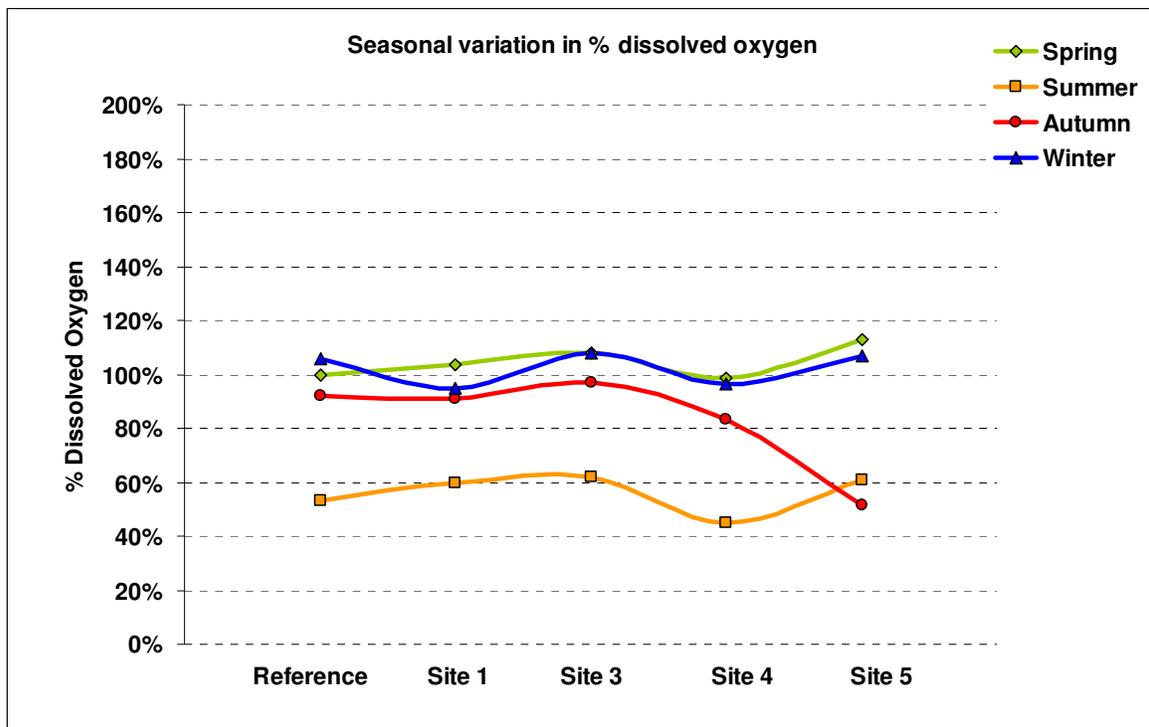
Figure 44: Seasonal variation in dissolved oxygen (2011 – 2012).

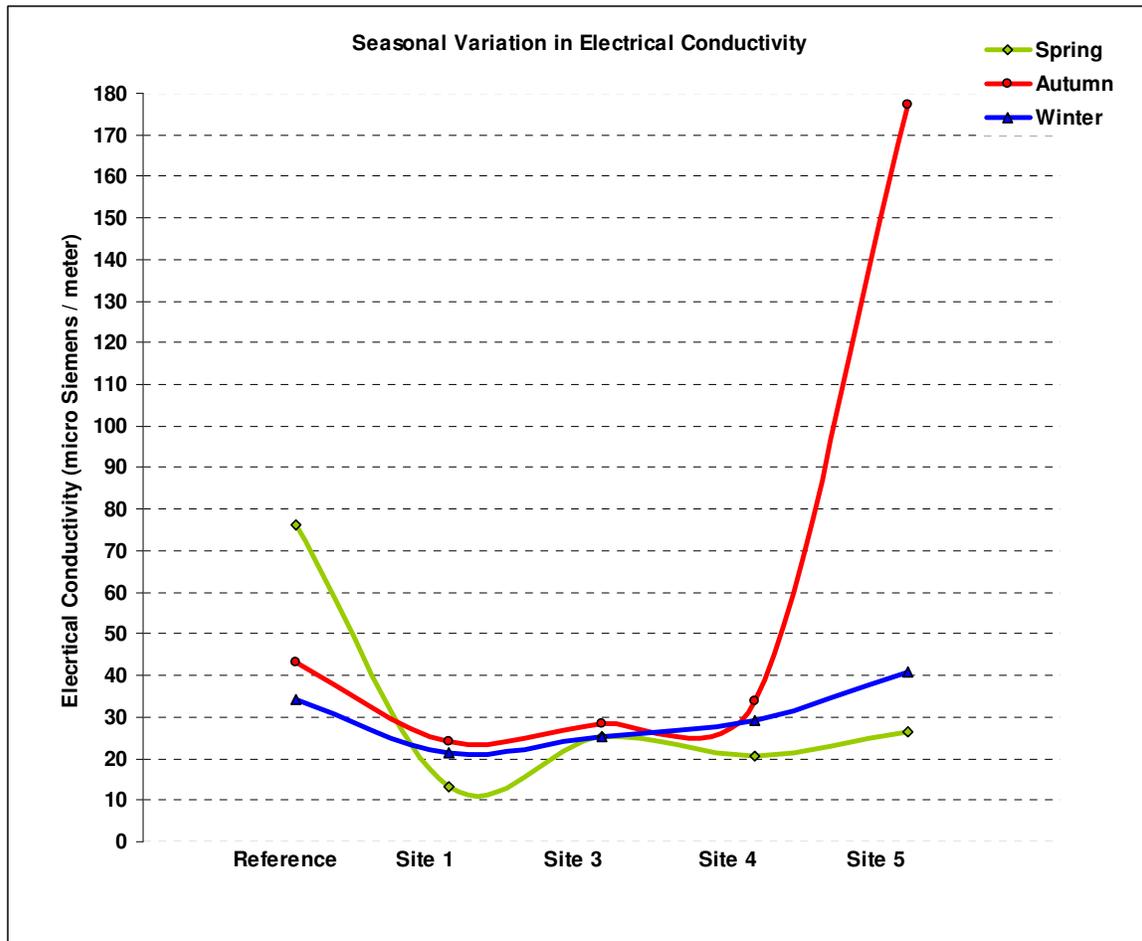
Figure 45: Seasonal variation in electrical conductivity (EC) (2011 – 2012).

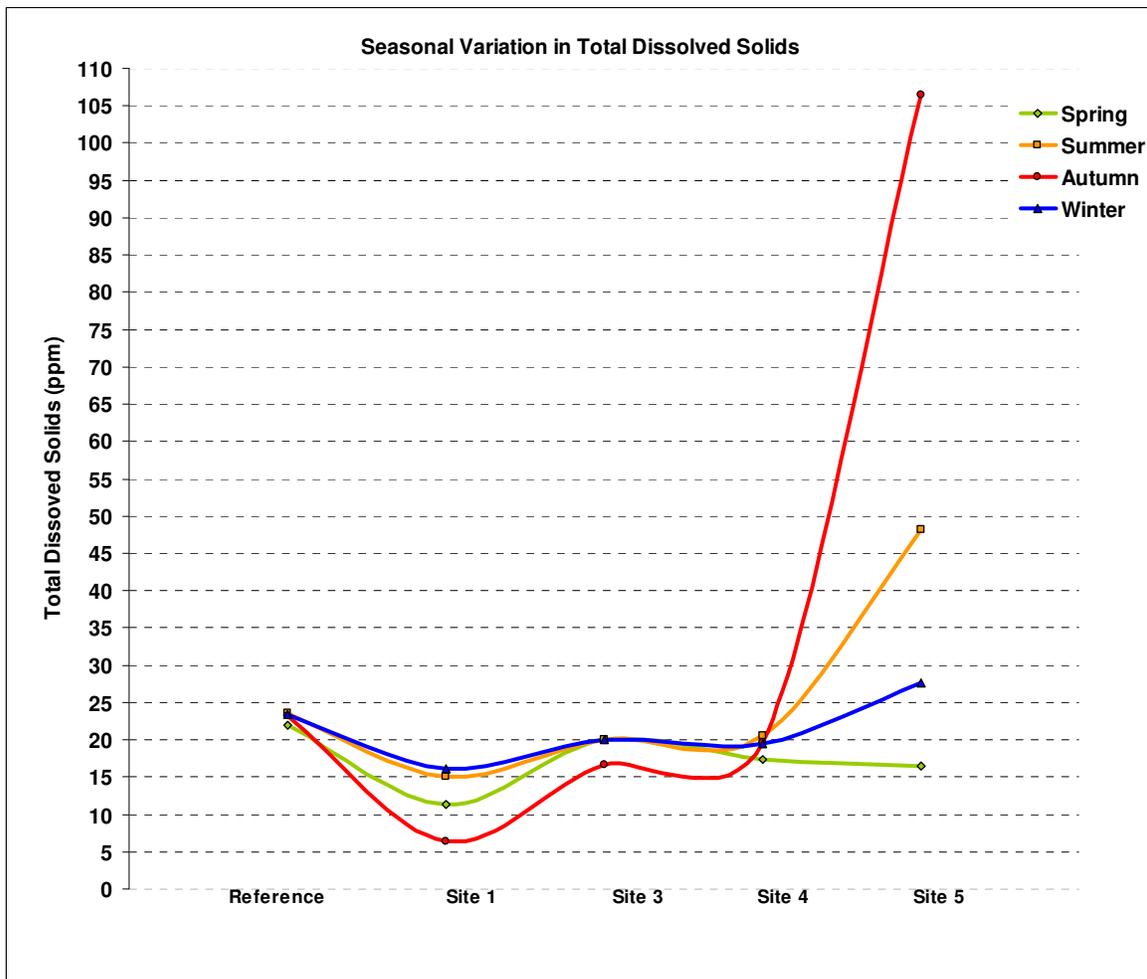
Figure 46: Seasonal variation in Total Dissolved Solids (TDS) (2011 – 2012).

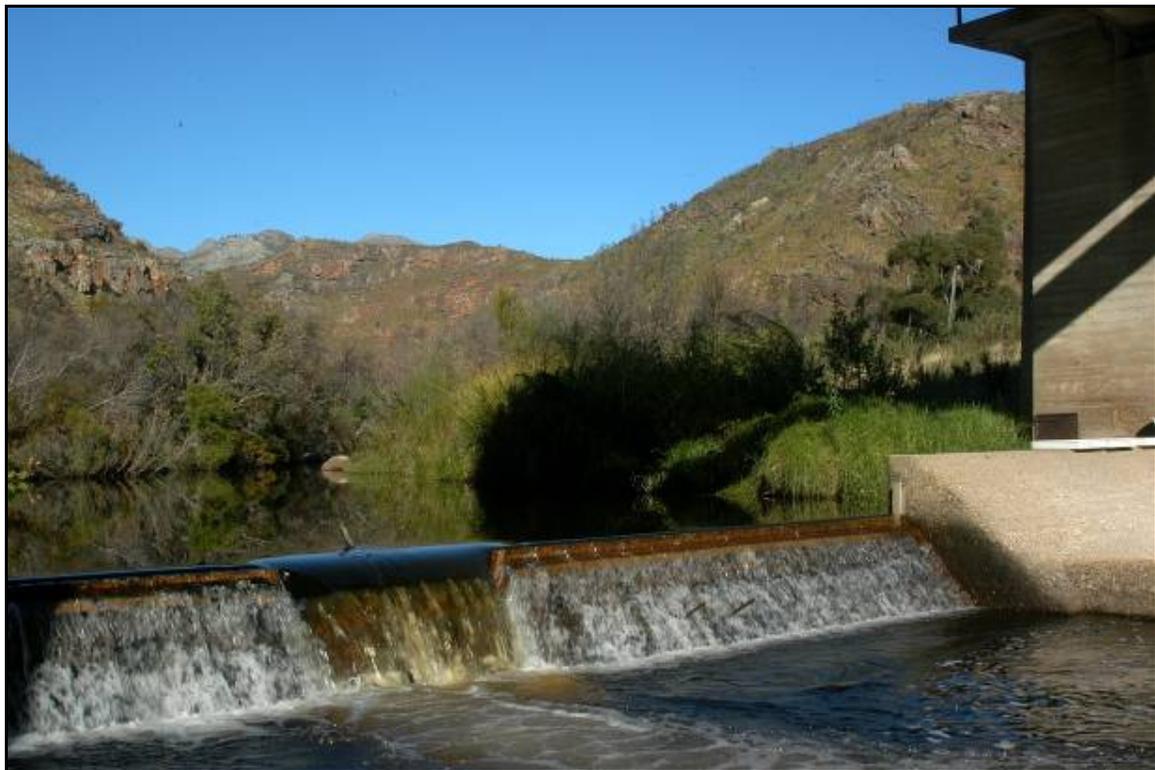
Figure 48: The gauging weir under the high-water bridge over the river downstream of the Stettynskloof Dam. The weir creates a large pool upstream where organic debris accumulates.

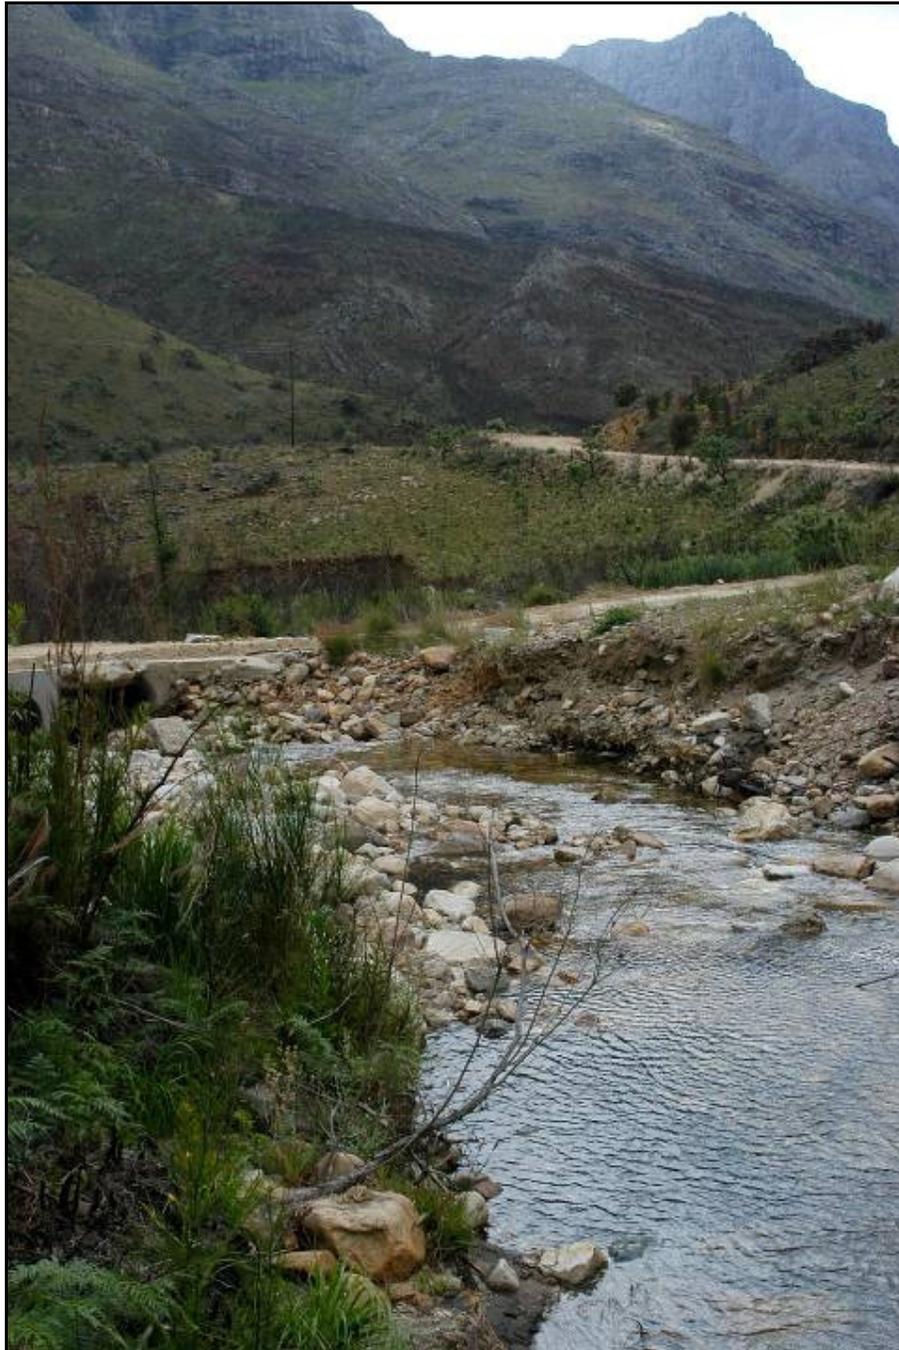
Figure 53: The low-flow causeway at Sampling Site 2 on the left-hand side of the picture (taken in summer 2011). Erosion of the northern bank is visible due to the pipes below the road not being able to let floodwater through efficiently. The effect of the fire in 2011 is visible on the slopes in the distance.

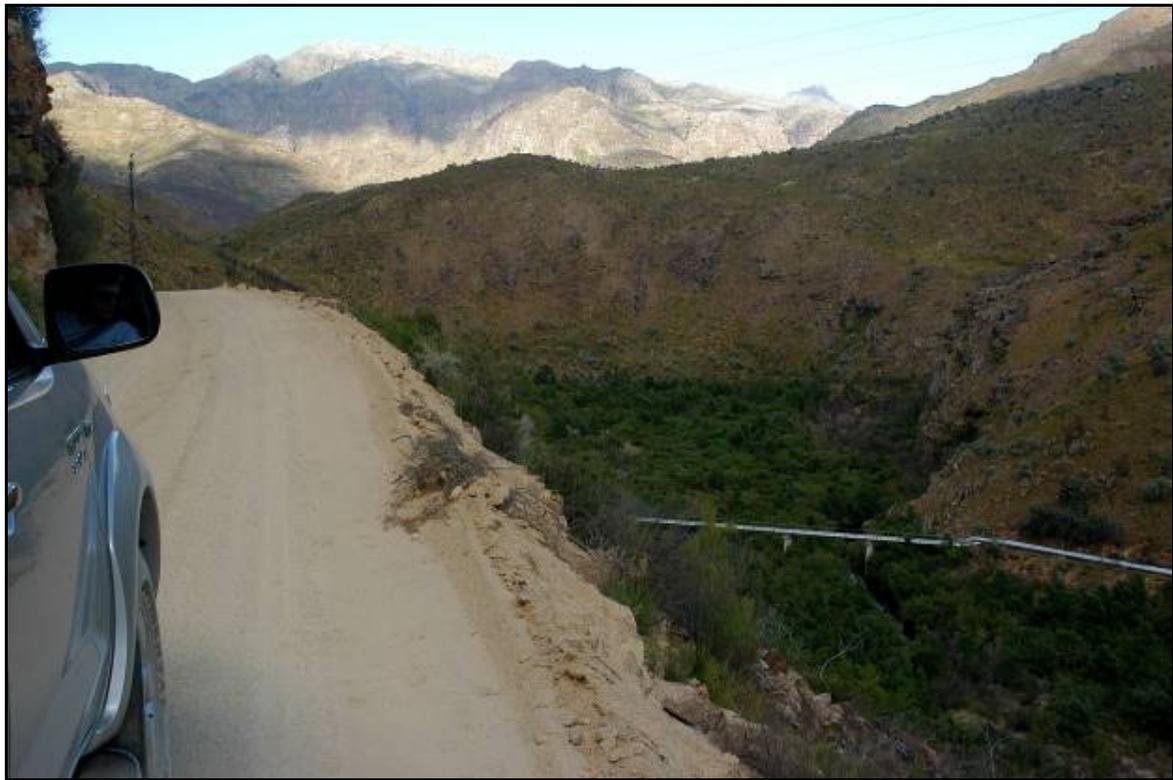
Figure 54: The upper catchment of the Holsloot River between Sampling Sites 2 and 3 (autumn 2012). The road and power line run high above the riparian zone, but the pipeline, mounted on high supports, crosses through the riparian zone.

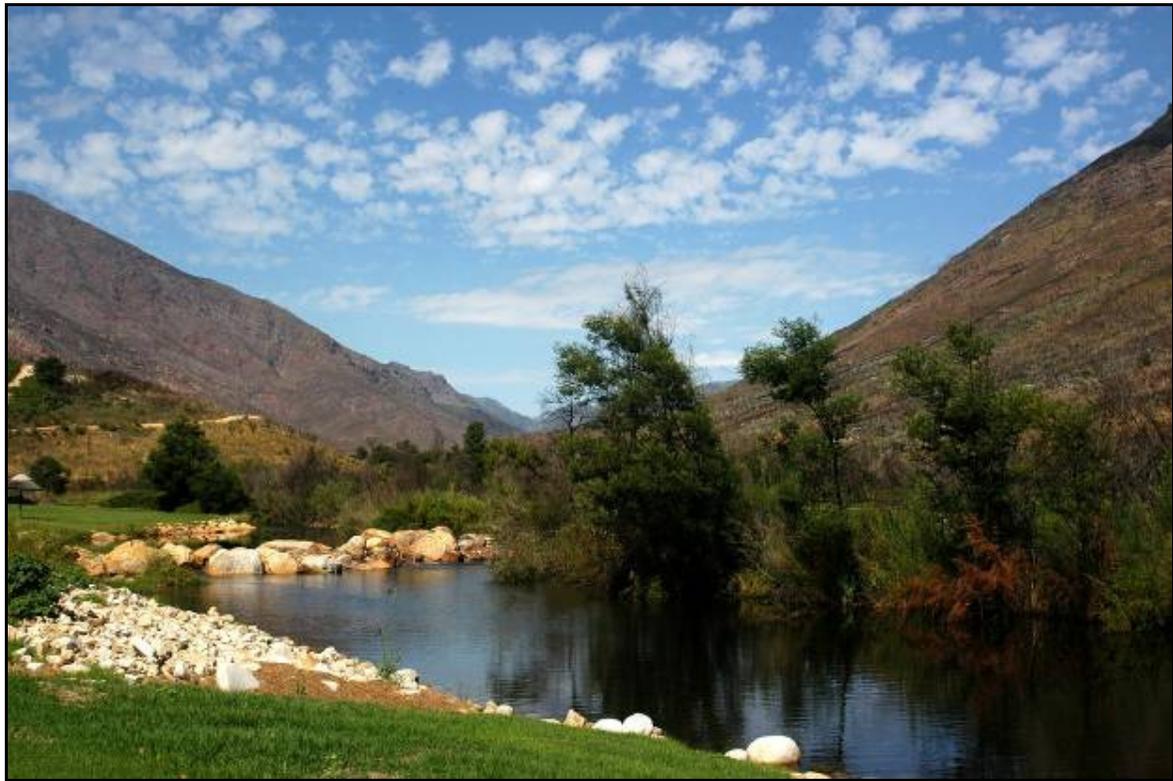
Figure 55: A cobblestone weir creates a pool at a picnic area at Sampling Site 3. *Acacia mearnsii* invasion is a problem in this area of the catchment.
