**AN ECOLOGICAL ASSESSMENT OF THE HOLSLOOT RIVER,
WESTERN CAPE, SOUTH AFRICA**

submitted in accordance with the requirements for the degree of

MASTER OF SCIENCE

UNIVERSITY OF SOUTH AFRICA

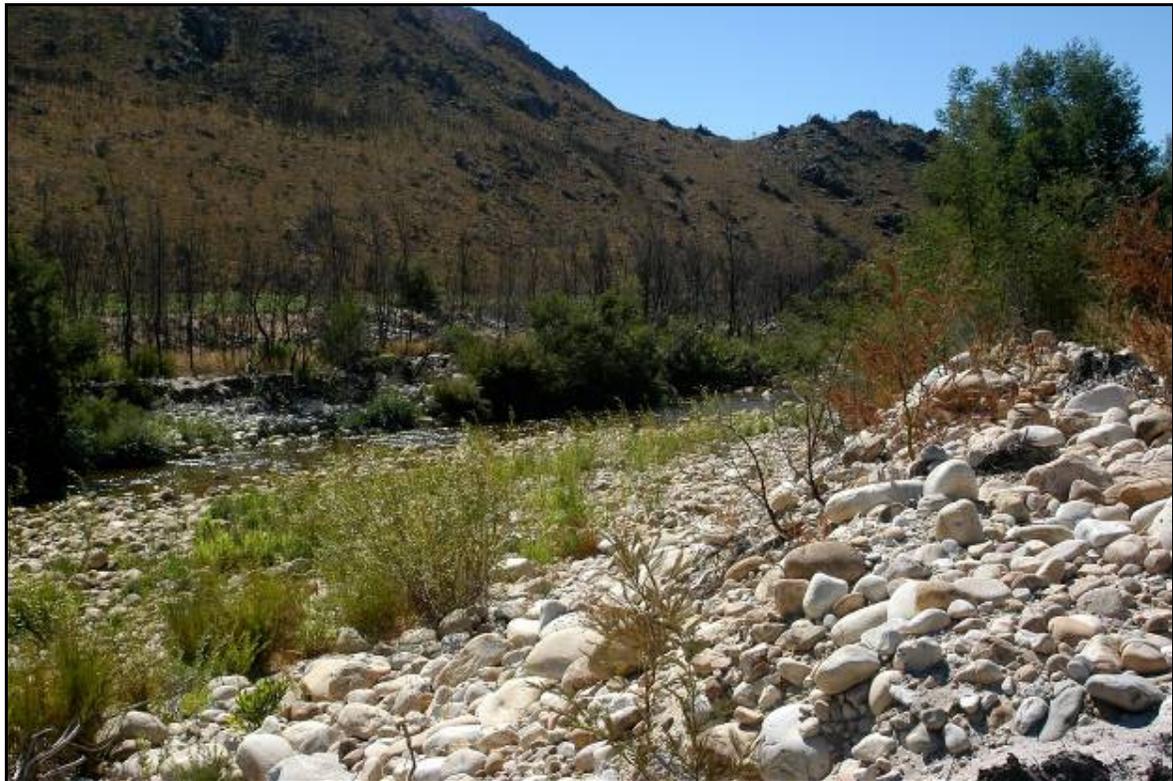
Figure 56: The condition of the Holsloot River near Sampling Site 4 with alien invader vegetation replacing natural vegetation in some places and marks of bulldozing in the riparian zone. Erosion is visible where banks are destabilized due to dense stands of especially *Acacia mearnsii*. In most areas, no buffer zone is maintained between vineyards and the riparian zone (autumn 2012).

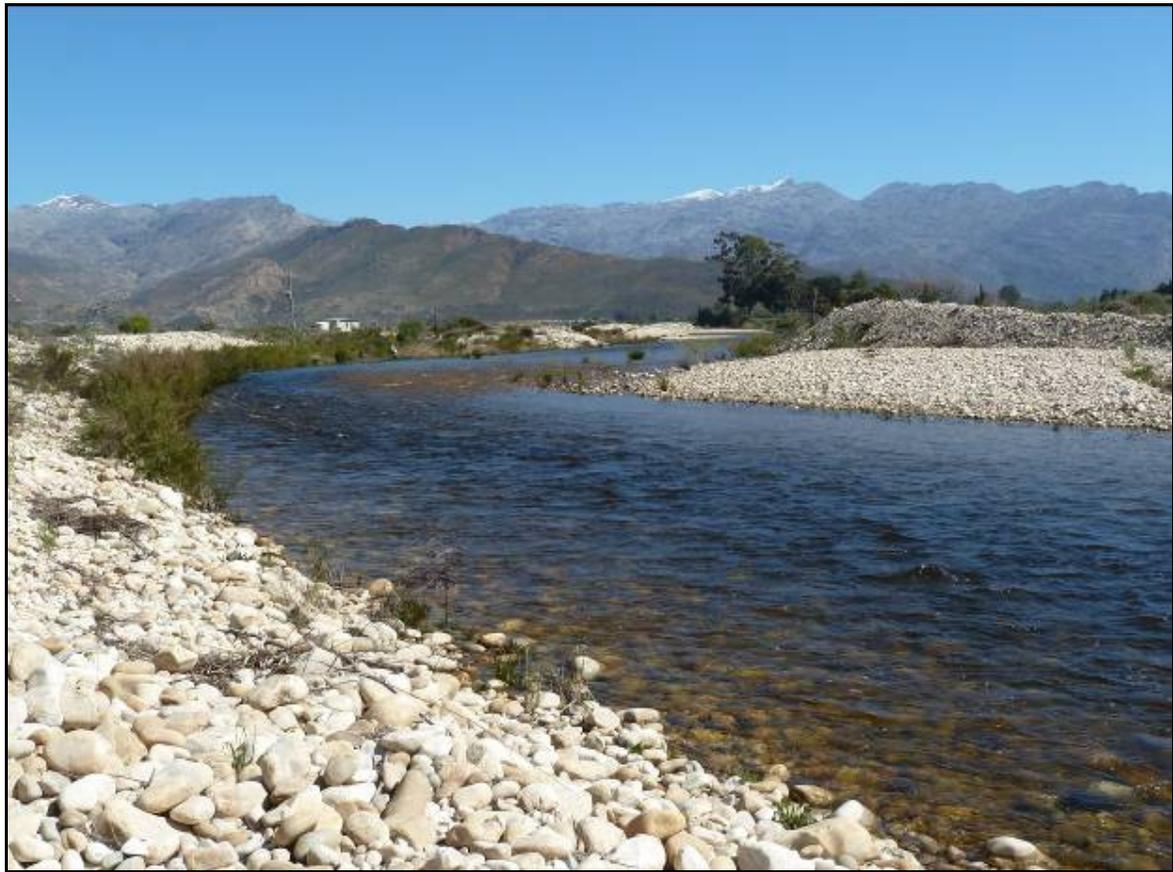
Figure 57: Due to seasonal bulldozing of the riverbed in the catchment area of Sampling Site 5, almost no riparian vegetation with associated habitat is left (Photo ME Brand, spring 2012).

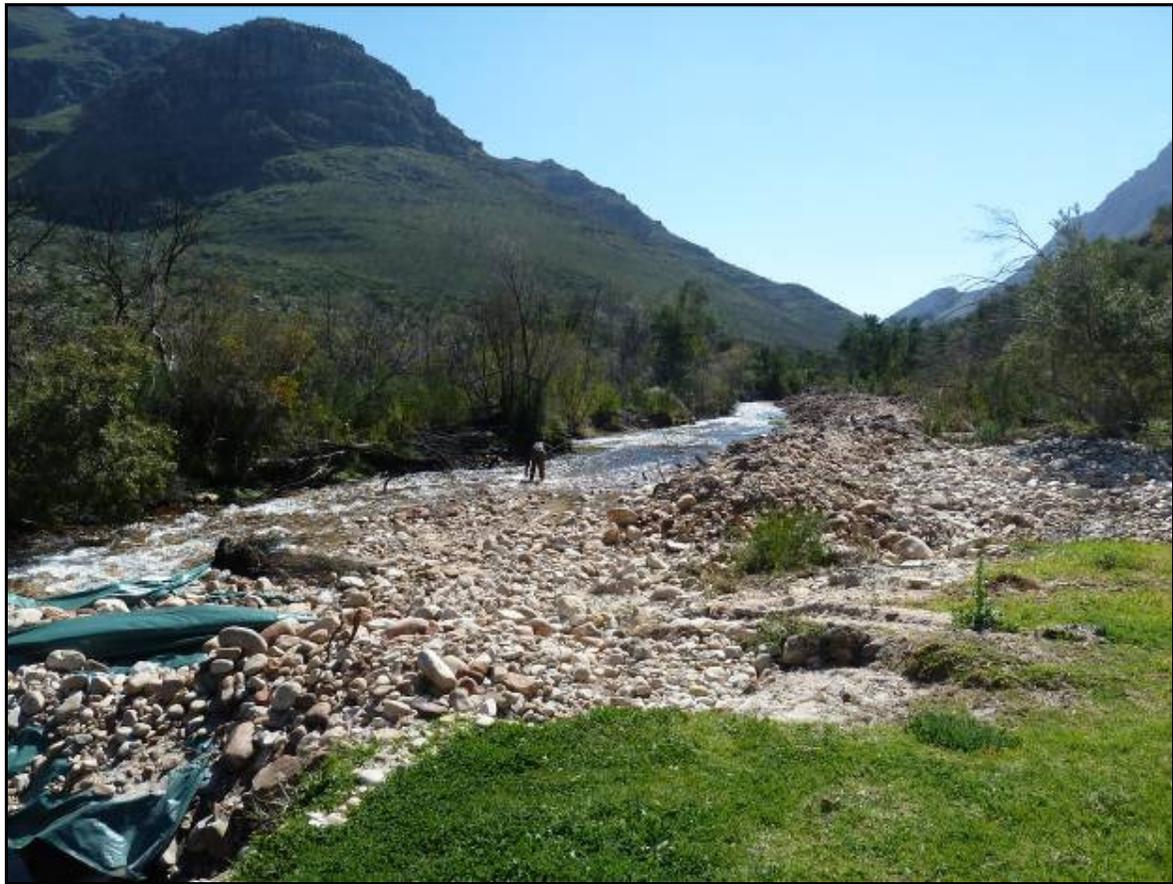
Figure 58: The effects of damming and occasional bulldozing can be seen at Sampling Site 3 in spring 2012 (Photo ME Brand).

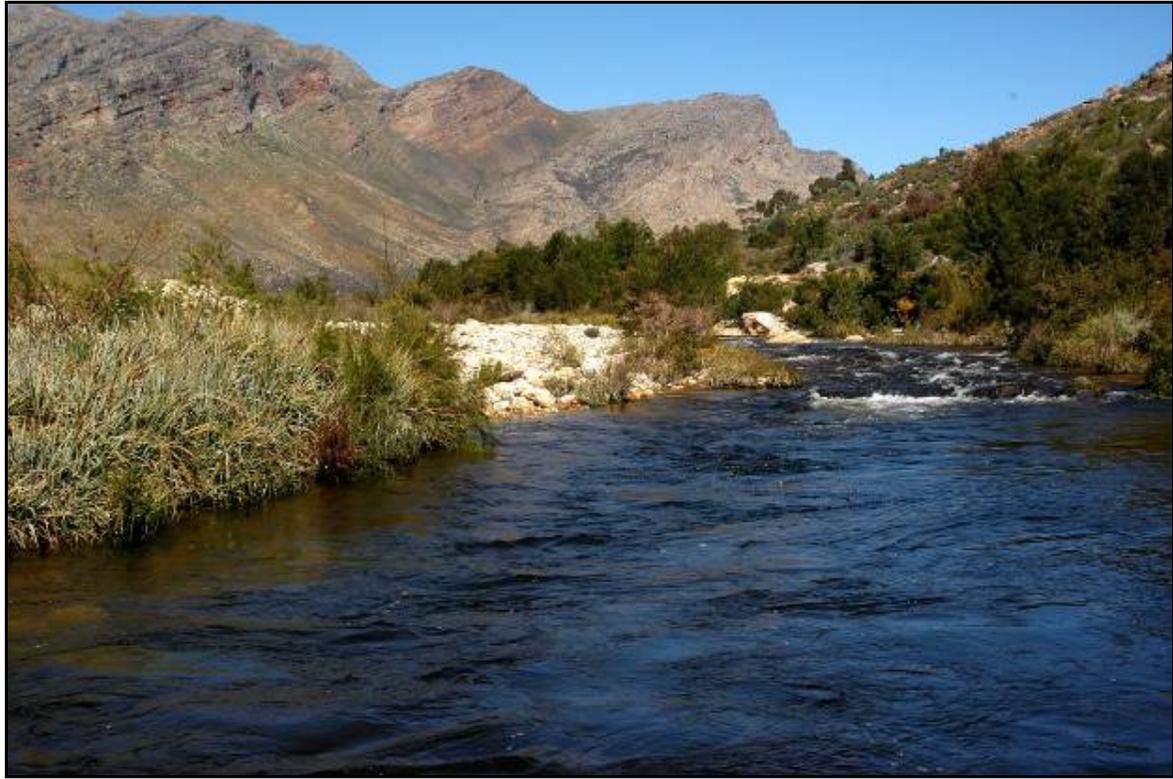
Figure 61: High water levels and strong flow, experienced in spring 2012 after good rains prior to the sampling, could have resulted in aquatic organisms being washed downstream with the strong current (Photo: ME Brand – Sampling Site 4).

found to be high in spring (Figure 61), but low in summer (Figure 37) and autumn (Figure 39) (Table 17).

Crabs (Crustacea: Potamonautidae), midge larvae (Diptera: Chironomidae), mosquito larvae (Diptera: Culicidae), aquatic earthworms (Annelida: Oligochaeta), and nymphs of dragonflies (Odonata: Libellulidae) were found at all the Sampling Sites (Table 21). Moth flies of the family Psychodidae (Diptera), which prefer stagnant puddles with decaying organic material in streams (Gerber & Gabriel 2002), were only once found during this study and at Sampling Site 4 in summer when the water level was moderately low. A giant water bug (Hemiptera: Belostomatidae) was found only in summer, and at Sampling Site 1 which provides the appropriate habitat as giant water bugs prefer the bottom of shallow pools in backwater areas or quiet areas of streams (Gerber & Gabriel 2002). Water scorpions, representatives of the family Nepidae (Hemiptera), were only found at Sampling Site 4 in spring. Although they can survive in conditions with low water quality, water scorpions are known to prefer shallow pools or slow flowing streams (Gerber & Gabriel 2002), but as the water level was high and the flow strong in spring, this taxa had supposedly washed down from an upper area in the river where appropriate habitat features are present (Figure 61). Similarly, is it possible

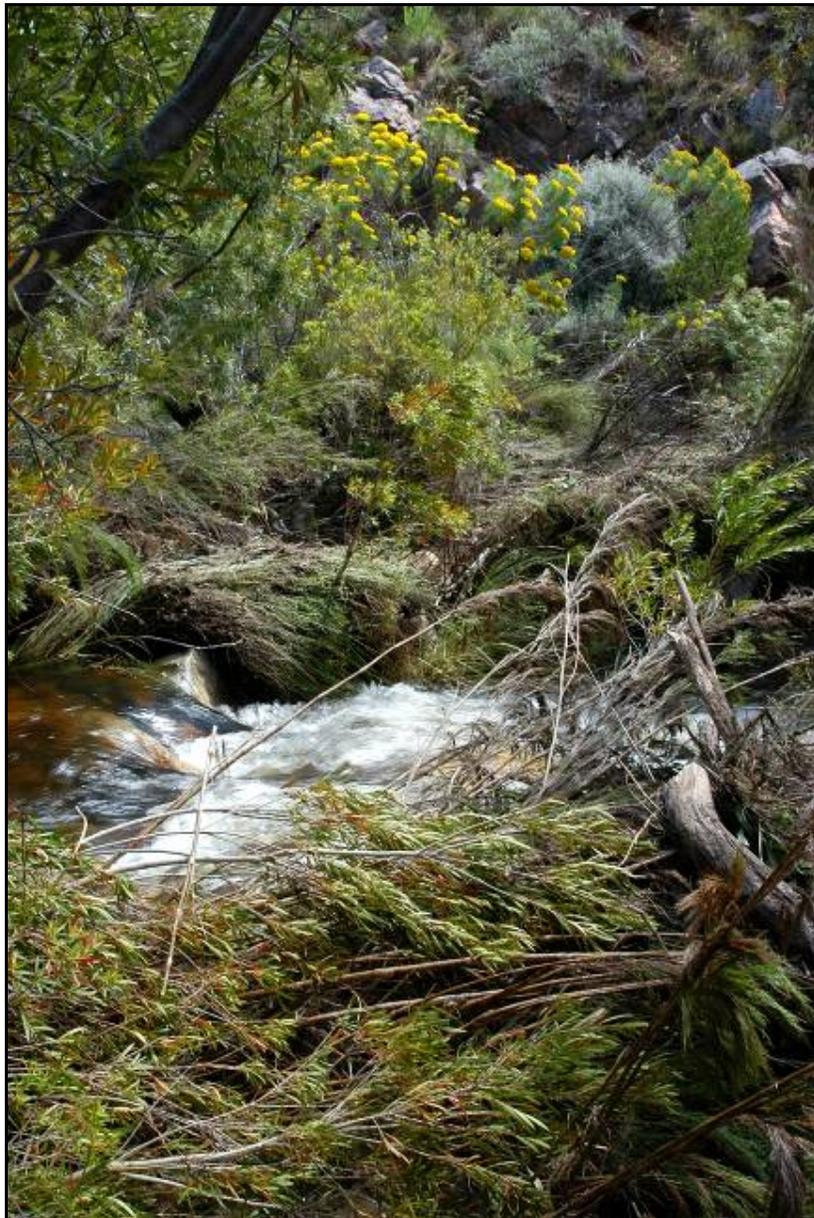
Figure 64: Natural floods cause opening of the riparian canopy through removal of indigenous vegetation. Tall *Morella integra* shrubs (in the foreground) and other riparian plants were uprooted during a flood in November 2008 at the Reference Site.

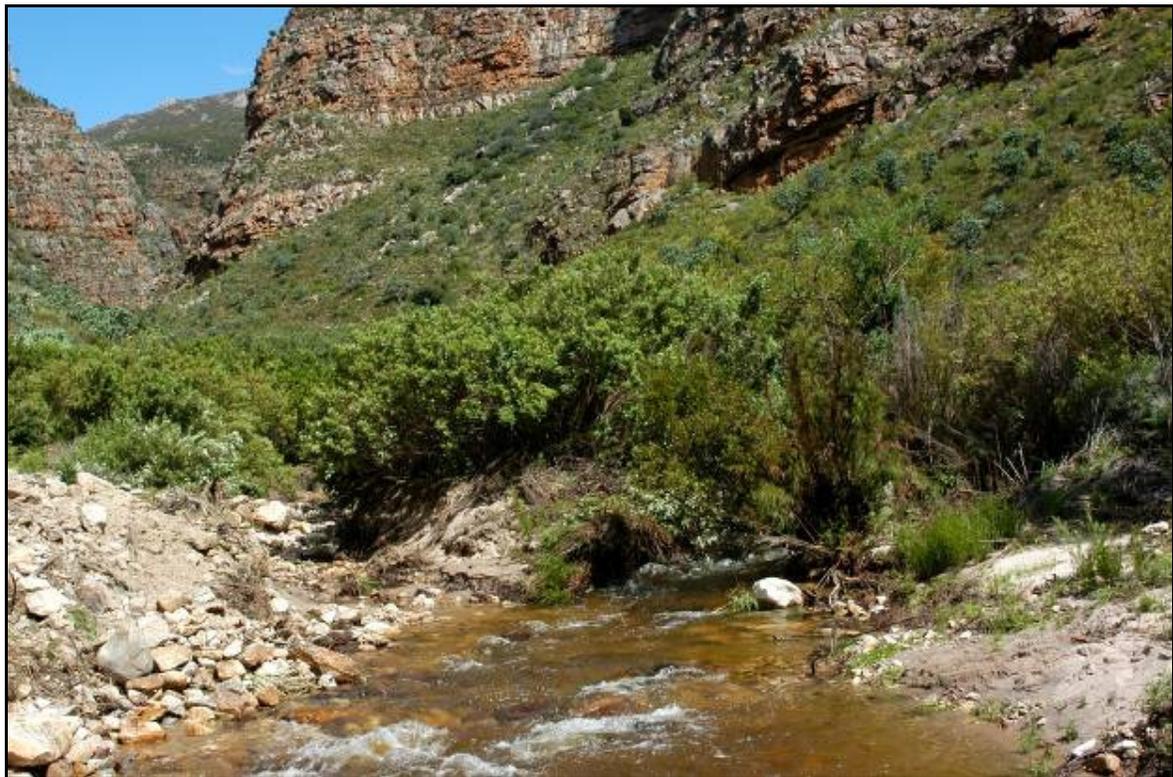
Figure 65: Infrequent bulldozing at the Reference Site to canalise stream flow towards the pipe under the low-flow causeway after flooding had caused accumulation of debris and deposition of sand at the causeway.

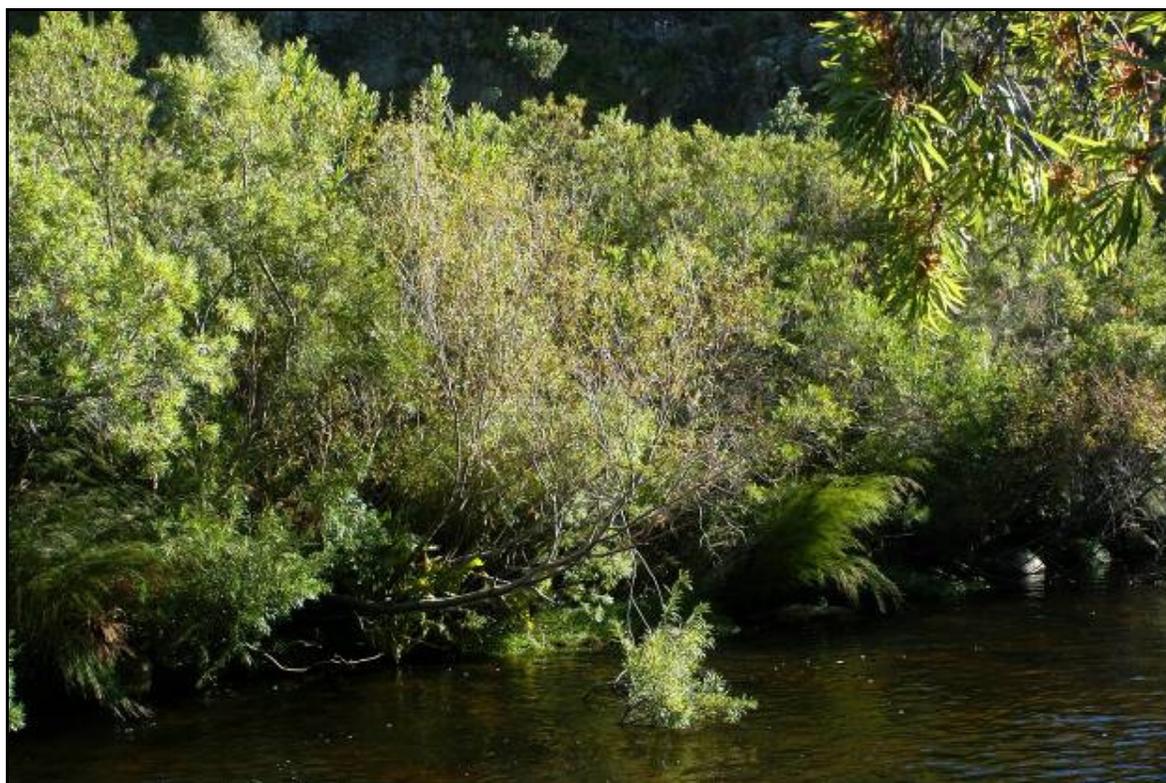
Figure 66: The densely vegetated marginal zone at Sampling Site 1 with woody *Brabejum stellatifolium*, *Morella integra* and *Metrosideros angustifolia* trees. *Elegia capensis*, *Isolepis prolifera* and *Zantedeschia aethiopica* are visible in the herbaceous layer.

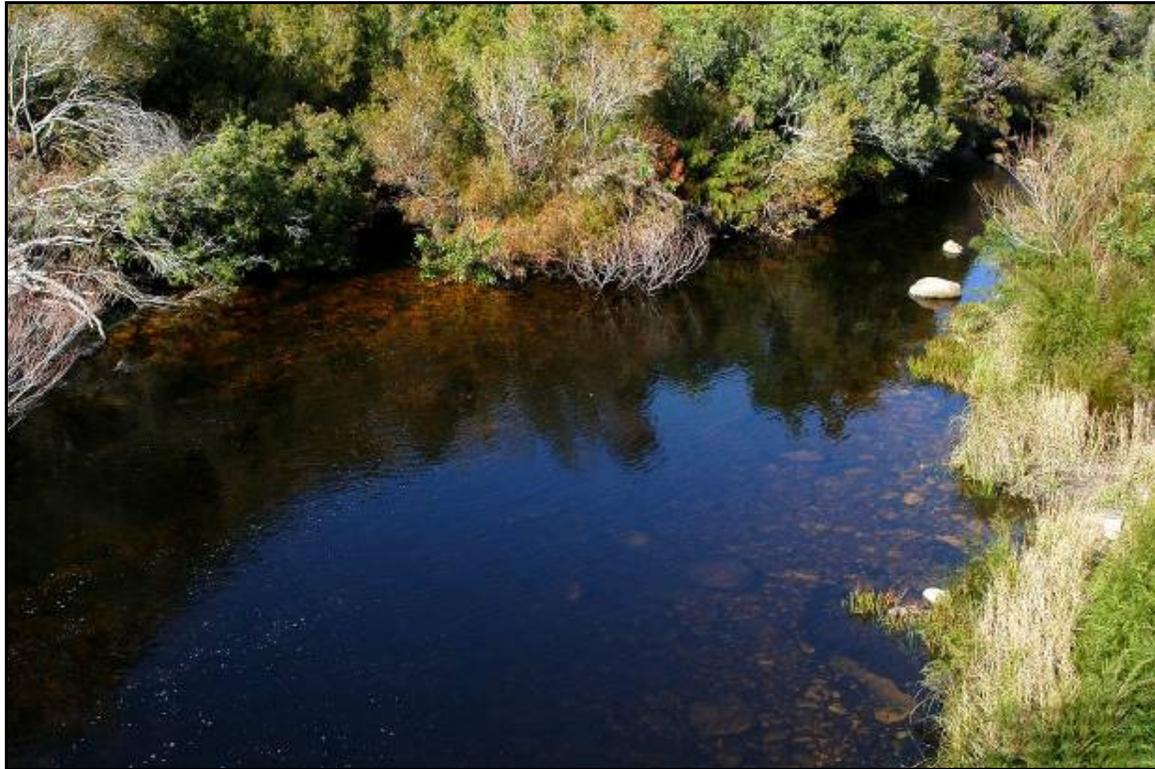
Figure 67: Because of the fairly deep pool character, the riparian vegetation at Sampling Site 1 is dominated by woody plants with sedges and grasses only in shallower areas such as on the western, more disturbed bank.

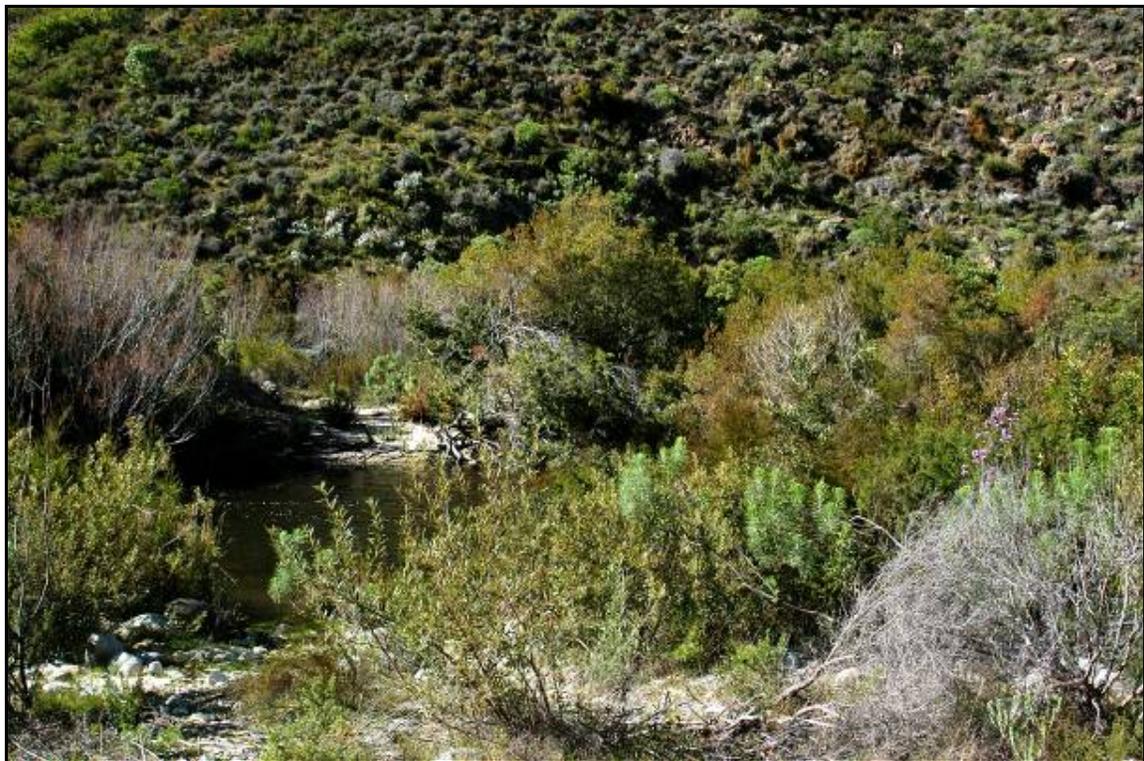
Figure 68: The Fynbos Riparian Vegetation in the riparian zone and Hawequas Sandstone Fynbos on the slopes at Sampling Site 1.

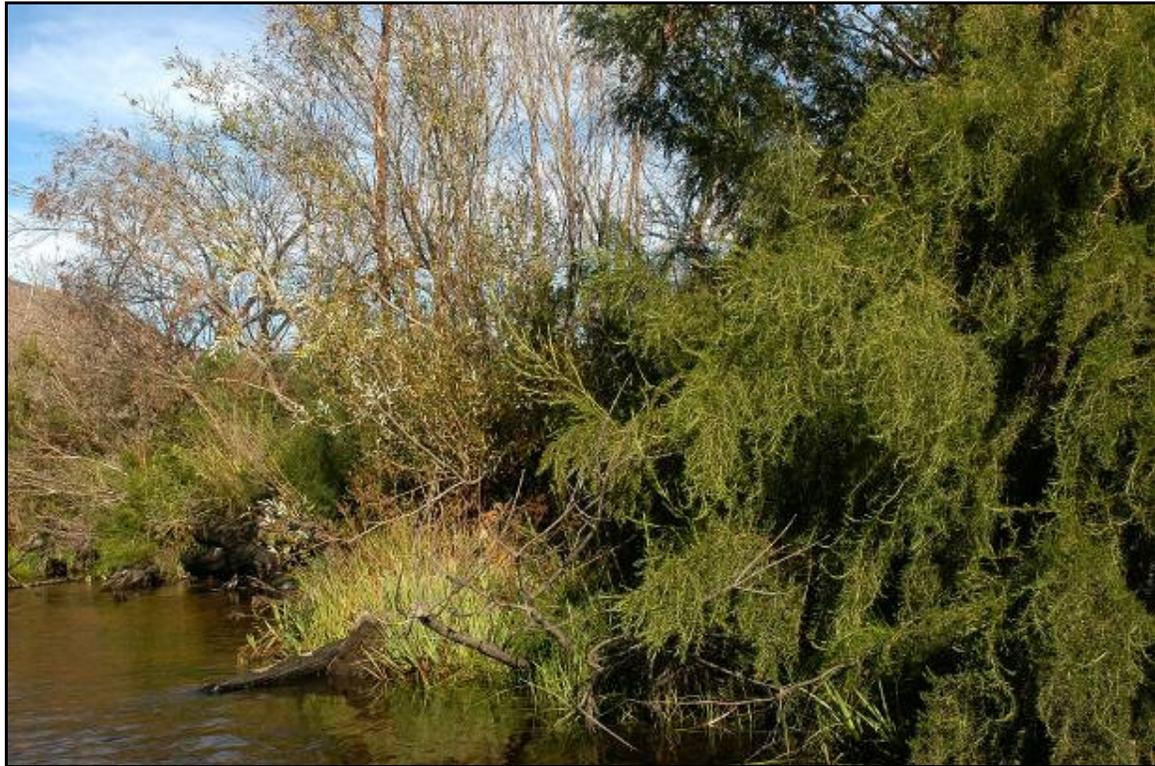
Figure 69: The marginal zone at sampling Site 3 with *Elegia capensis*, *Salix mucronata*, *Juncus lomatophyllus* and *Cliffortia strobilifera* in the foreground. The trees in the background are *Morella integra* and the alien invader *Sesbania punicea*.

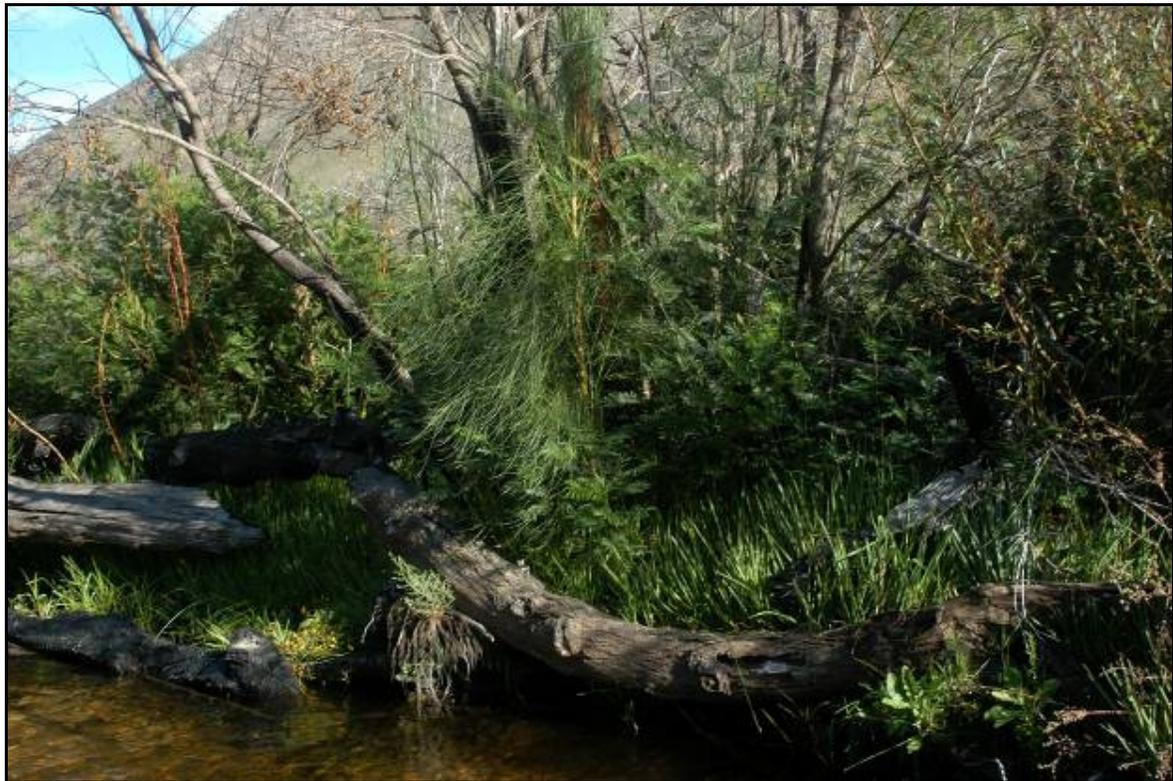
Figure 70: Recruitment of the invader *Acacia mearnsii* is a problem at Sampling Site 3 after the fire in 2011.

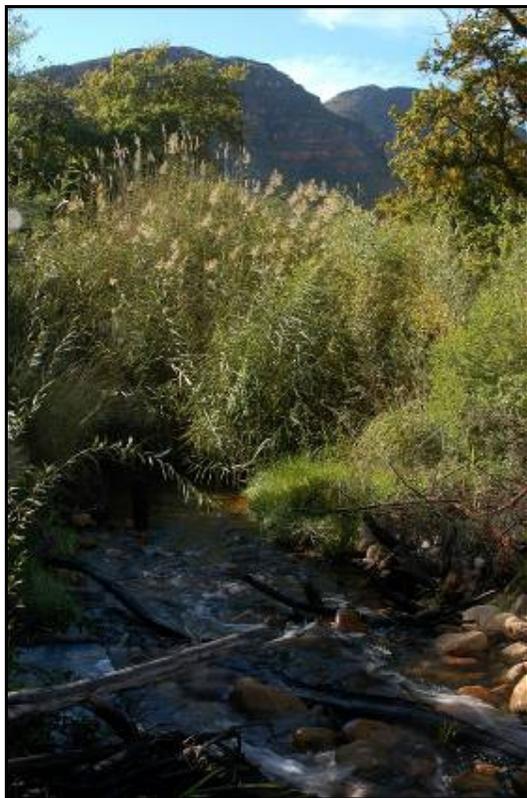
Figure 71: Dense riparian vegetation at Sampling Site 3 includes grasses and sedges a stand of *Phragmites australis* reeds, *Salix mucronata* and young *Acacia mearnsii* trees. The large trees are *Quercus robur*.

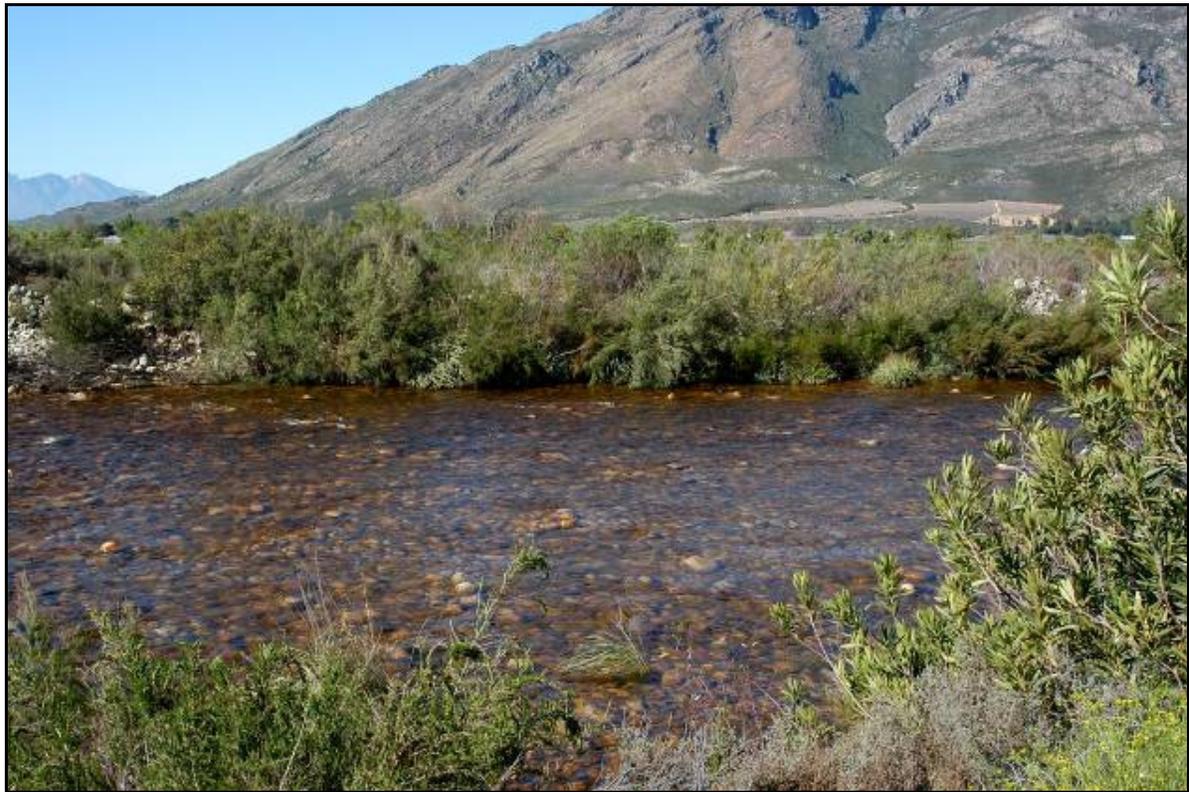
Figure 72: The riparian vegetation on the banks at Sampling Site 4 includes *Brabejum stellatifolium* and *Cliffortia strobilifera* (in the foreground).

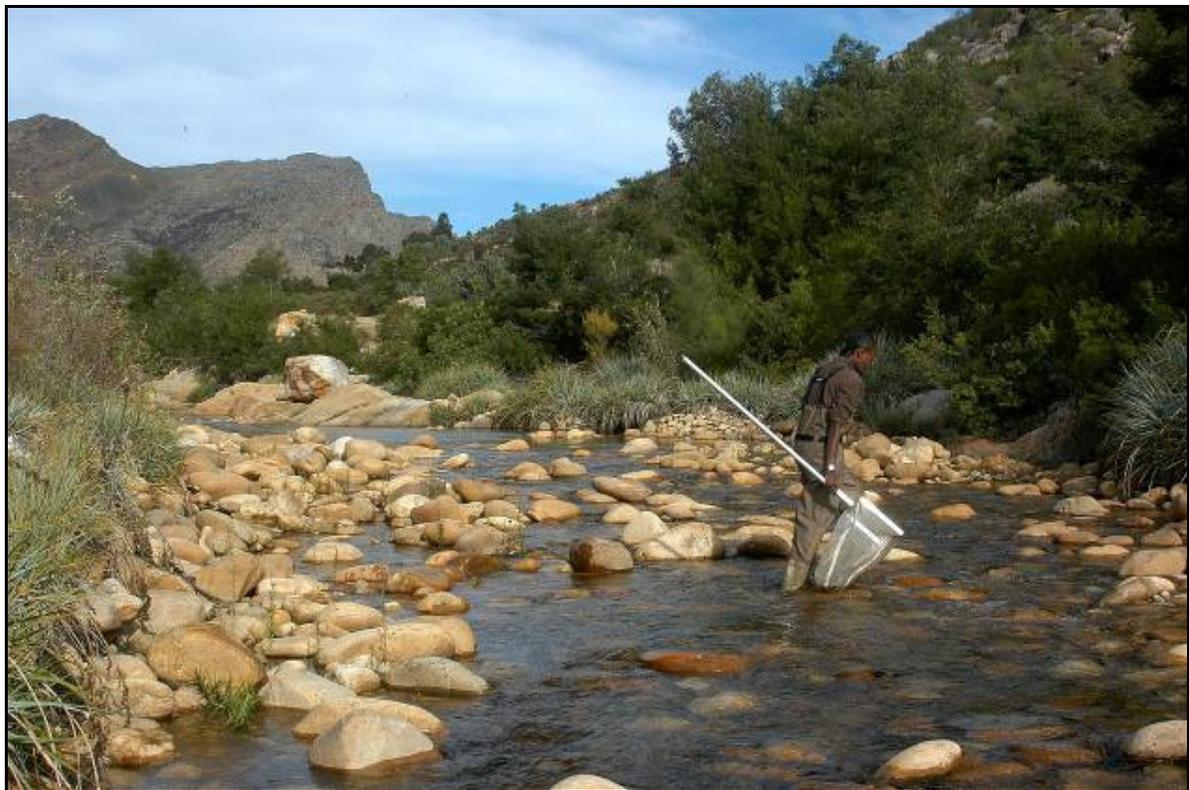
Figure 73: *Acacia mearnsii* thrives in the lower zone and on the banks at Sampling Site 4, while *Prionium serratum* and *Salix mucronata* dominates the marginal zone.

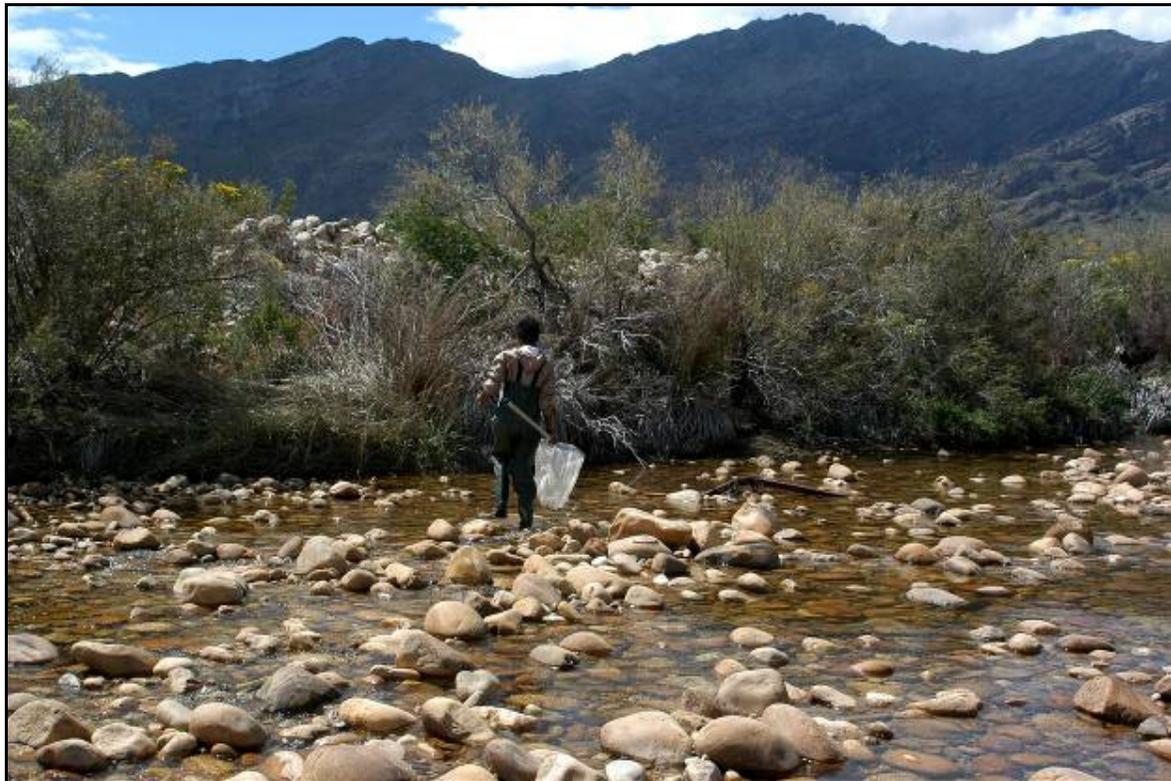
Figure 74: Yellow flowered *Hymenolepis parviflora* can be seen in the disturbed non-marginal zone at Sampling Site 4 where a cobblestone levee is maintained.

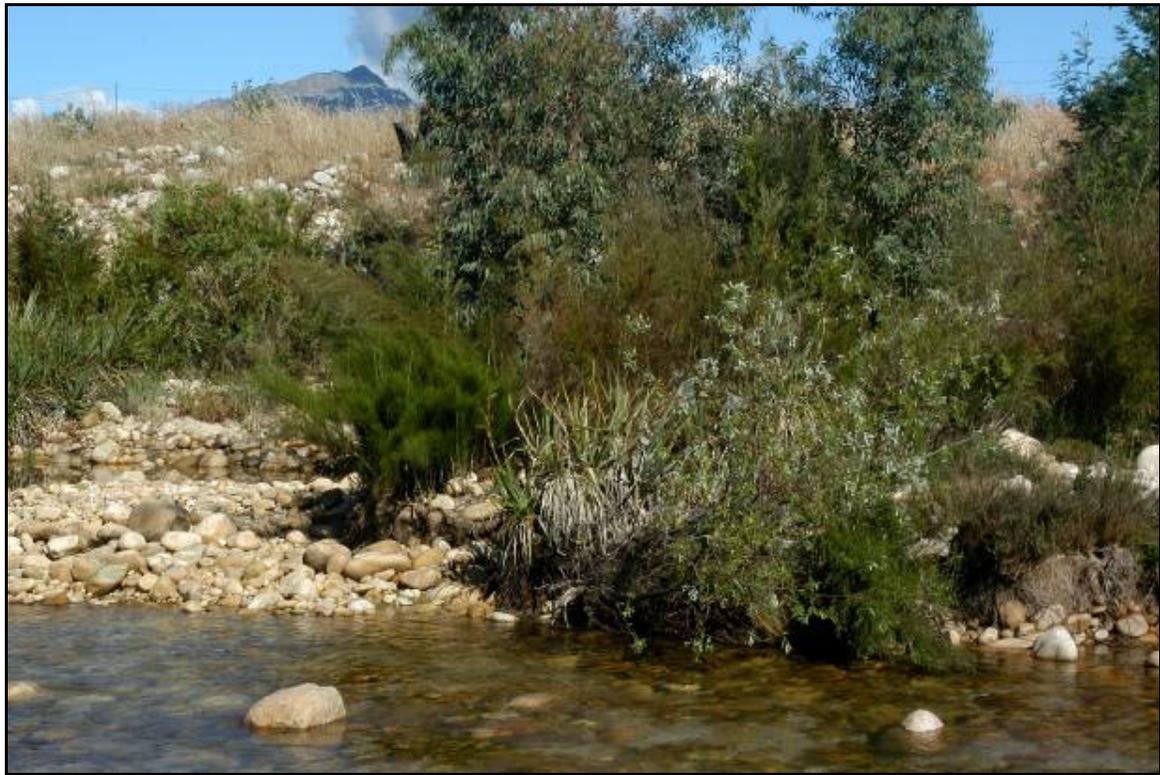
Figure 75: The riparian zone at Sampling Site 5 is characterised by disturbance and infested with alien invader plants. Here, *Prionium serratum*, *Cliffortia strobilifera*, *Elegia capensis* and *Salix mucronata* are interspersed with alien invaders *Acacia mearnsii* and *Eucalyptus cladocalyx*. The upper zone is covered in grass.

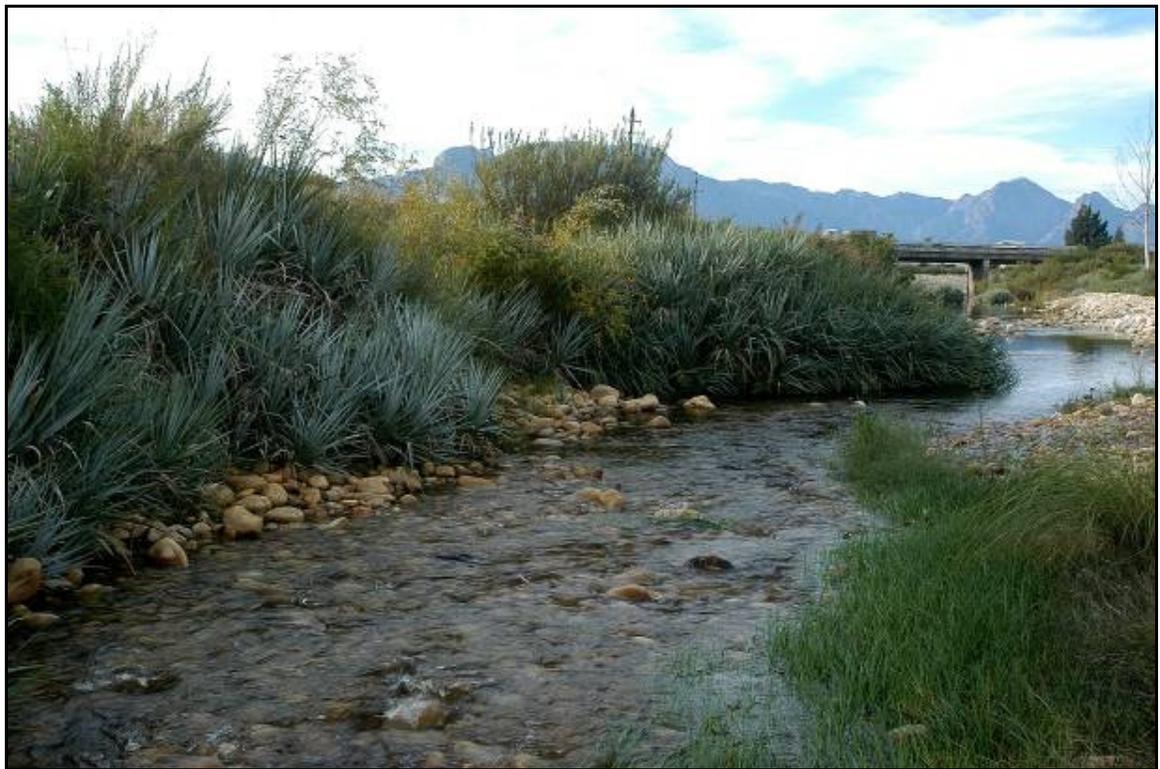
Figure 76: *Prionium serratum* (palmiet) plays an important role in stabilization of the riverbanks, not only here at sampling Site 5, but also all along the Holsloot River.
