**ANTHROPOCENTRIC IMPACTS ON THE ECOLOGY AND BIODIVERSITY OF
THE NATALSPRUIT WATERCOURSE AND ITS ASSOCIATED WETLANDS**

Submitted in accordance with the requirements for the degree of

MASTER OF SCIENCE

University of South Africa (UNISA)

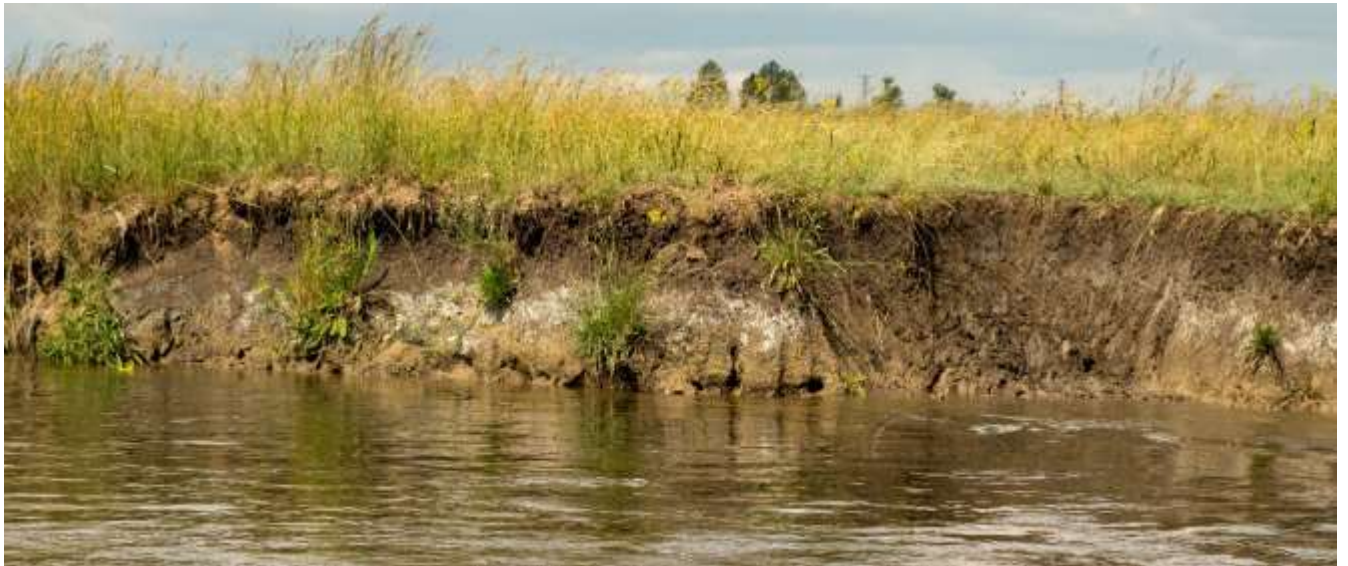
Figure 2.5: Hutton clay/loam soil representation of the Natalspruit (Source: Brits, 2018).

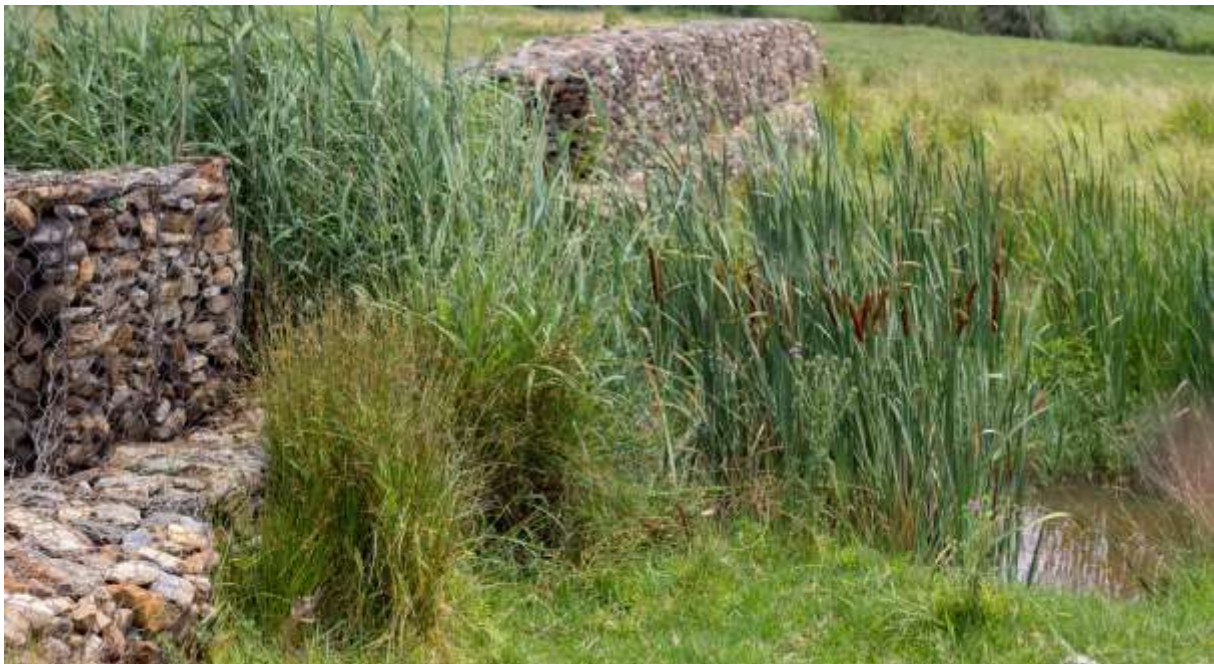
Figure 4.5: Degraded gabions erected to prevent this section of the Natalspruit from creating a second stream (especially during periods of heavy rainfall) which would undermine a road bridge (in Masakhane Street, Katlehong). Cattails are growing between the broken gabions (Source: Brits, 2018).

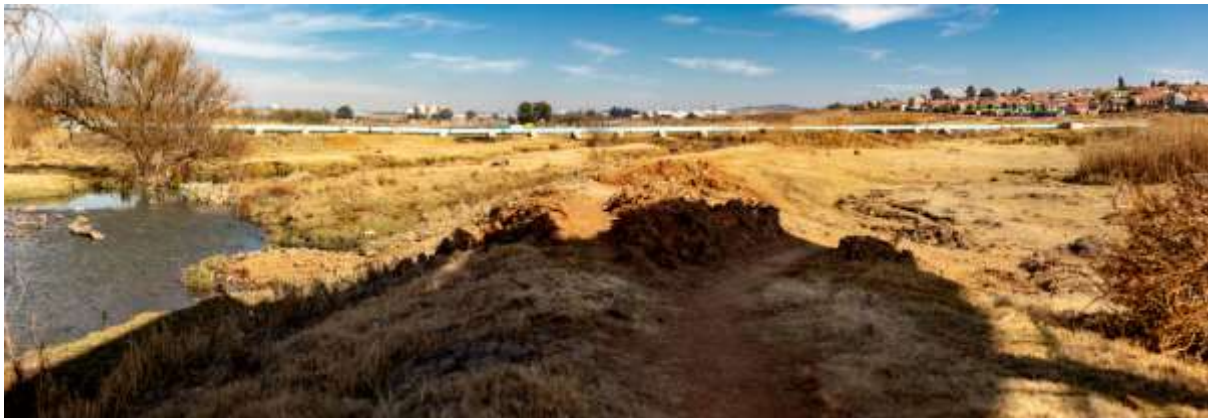
Figure 4.6: Further degradation of the wetland was observed in July after bulldozers had bulldozed large parts of the site in order to eliminate the accumulation of stagnant water (Source: Brits, 2018).

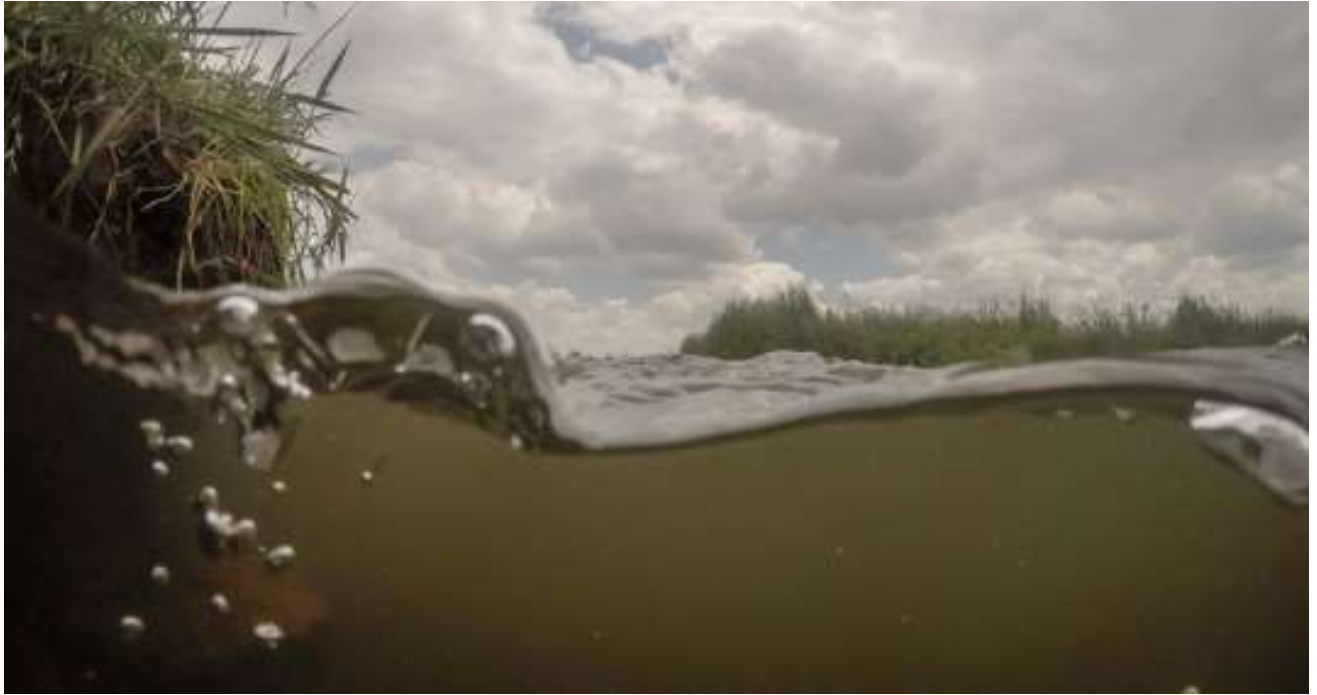
Figure 4.11: This picture was taken with a dome and GoPro camera to indicate the fast flowing motion of the watercourse as well as its turbidity (Source: Brits, 2018).

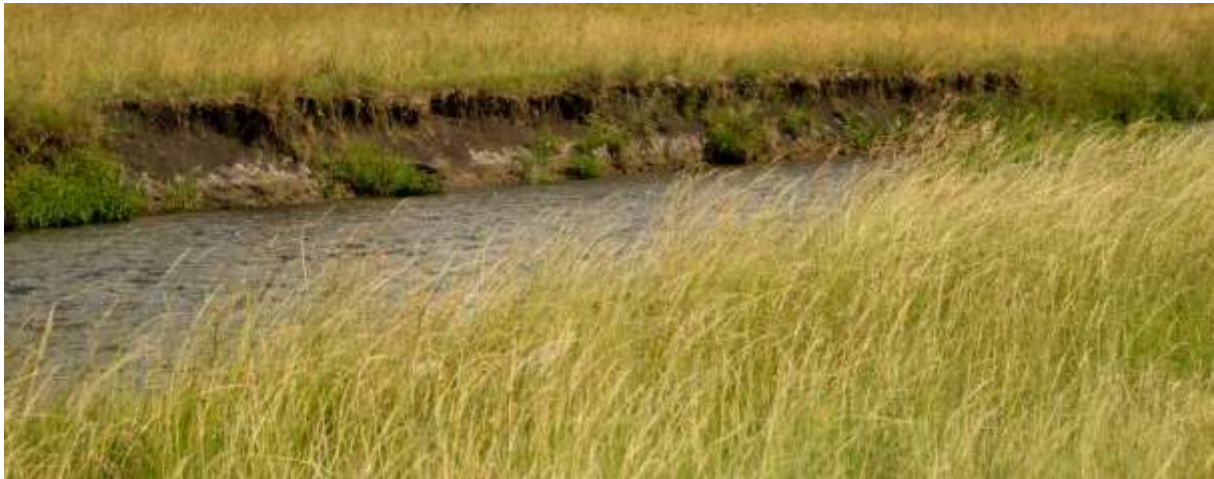
Figure 4.13: More riverbank erosion exposing different layers of soil (Source: Brits, 2018).

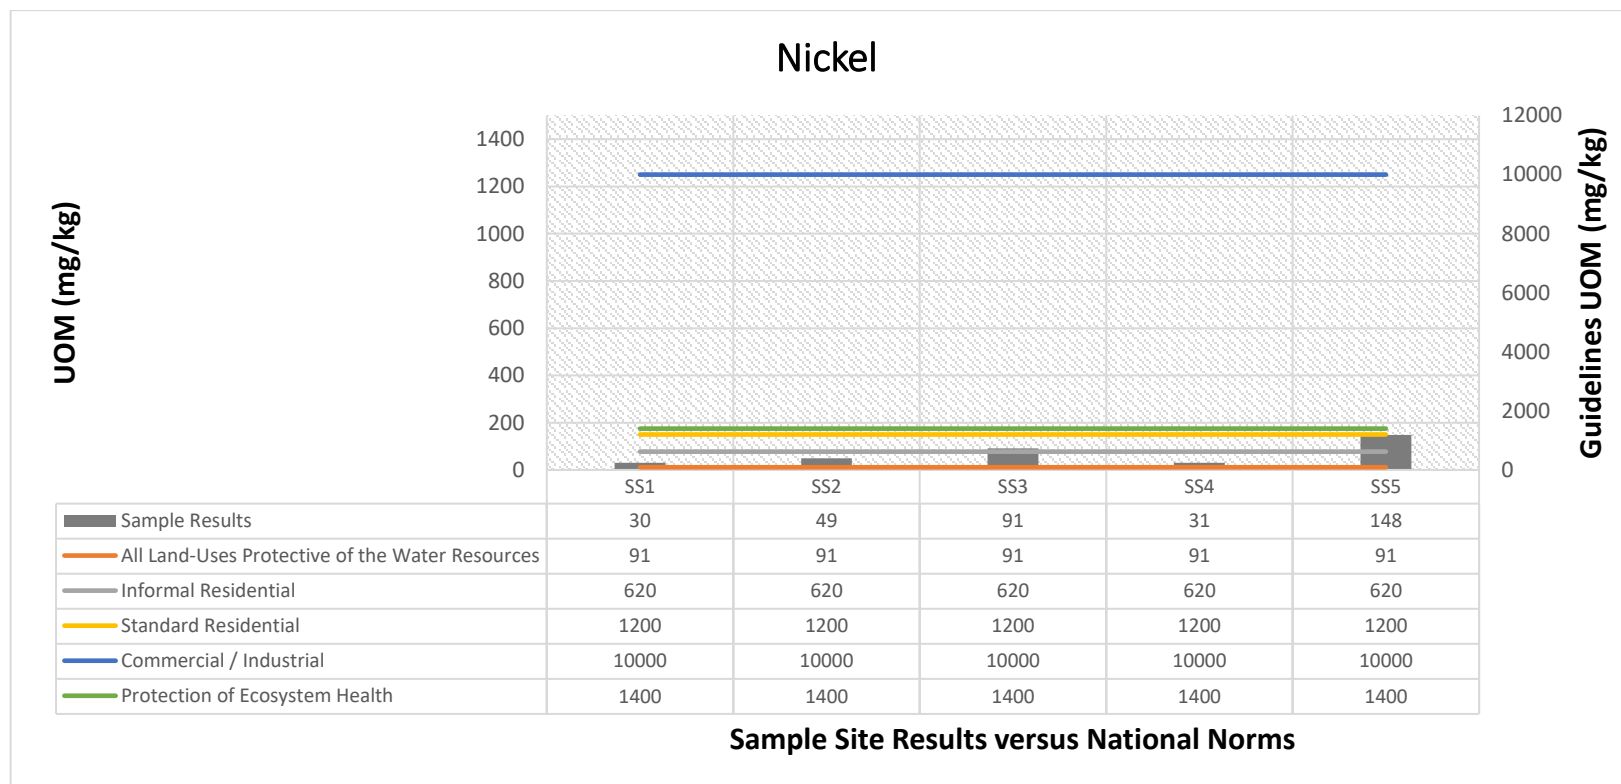
Figure 6.4: Ni concentrations in the soil samples compared to the National Norms and Guidelines.

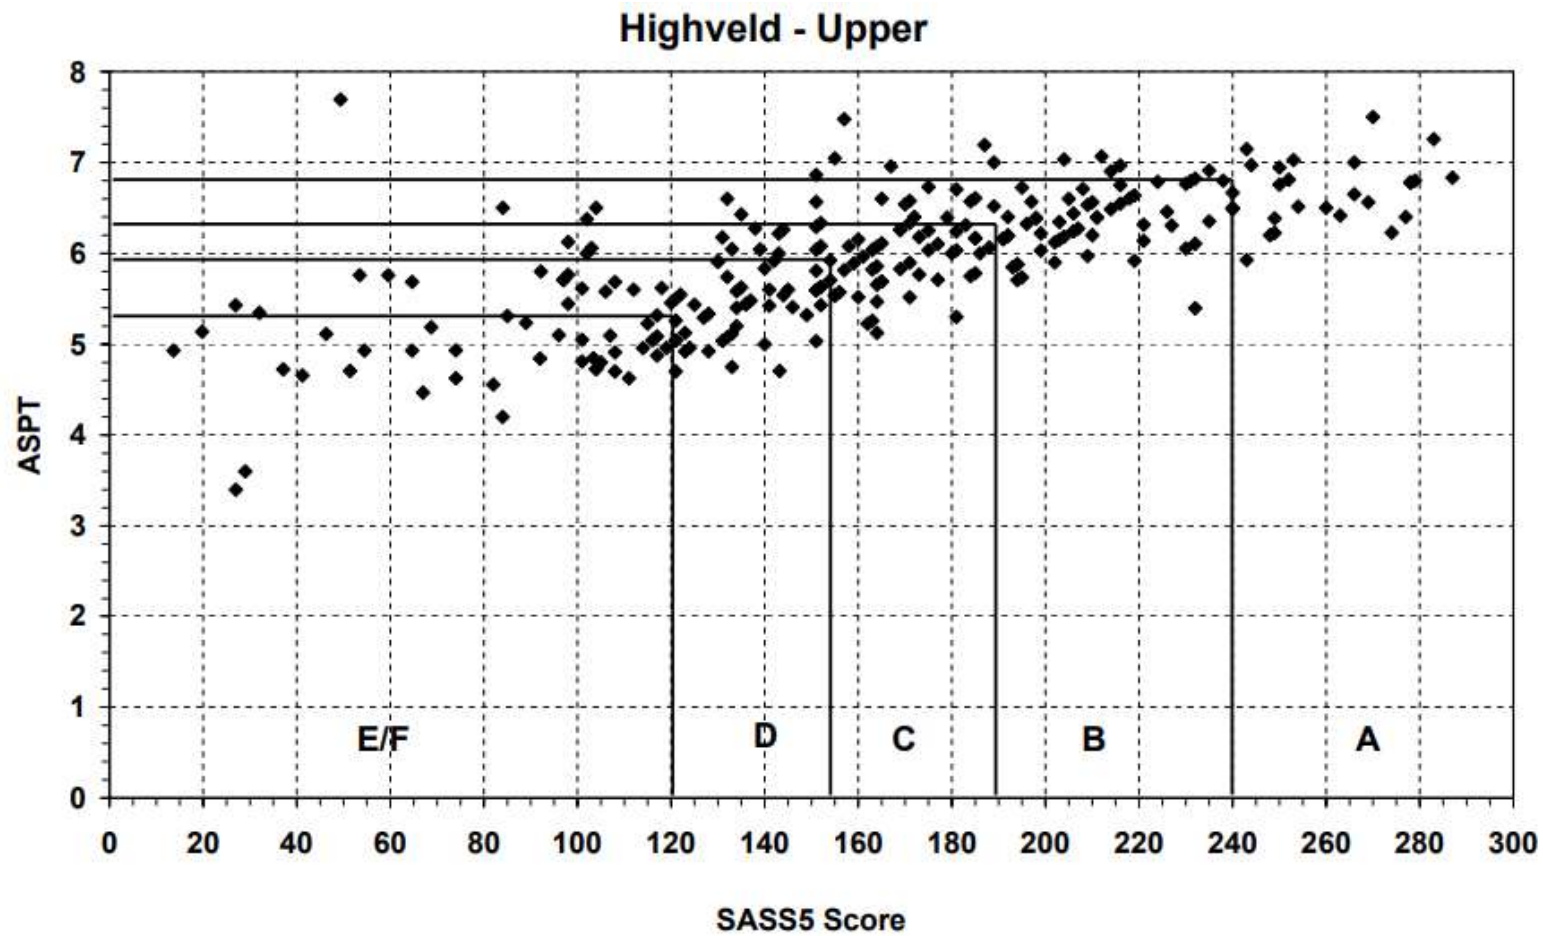
Figure 7.8: Biological bands for the Highveld (Upper), calculated from percentiles (Source: Dallas, 2007).

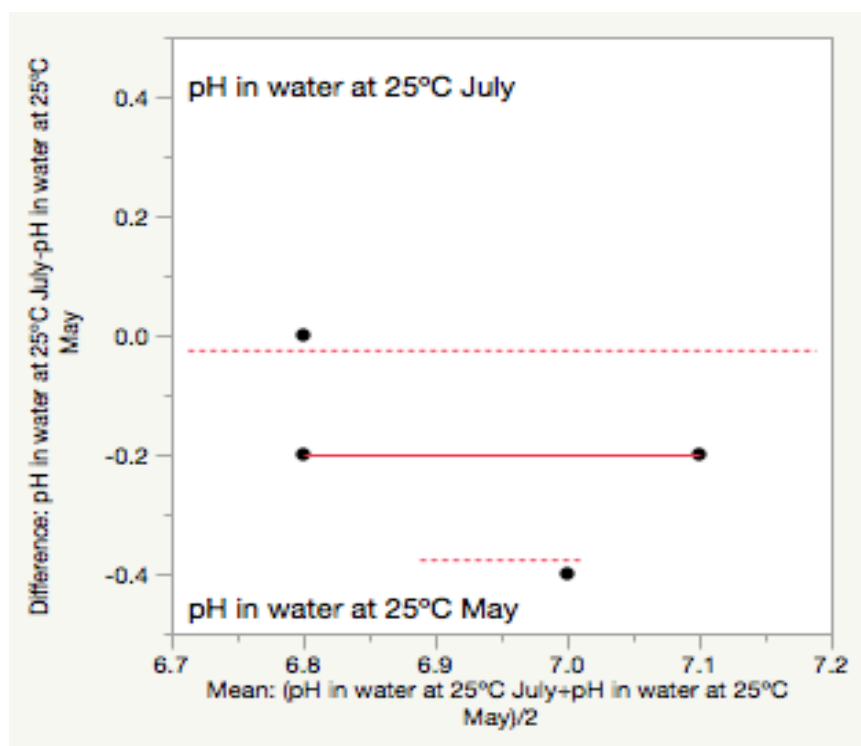
Figure 8.1: Statistical seasonal differences between May and July for pH 25 °C.
