**AN EVALUATION OF THE CUMULATIVE SURFACE WATER POLLUTION  
WITHIN THE CONSOLIDATED MAIN REEF AREA, ROODEPOORT, SOUTH  
AFRICA**

**MASTER OF SCIENCE**

**ENVIRONMENTAL SCIENCE**

**UNIVERSITY OF SOUTH AFRICA**

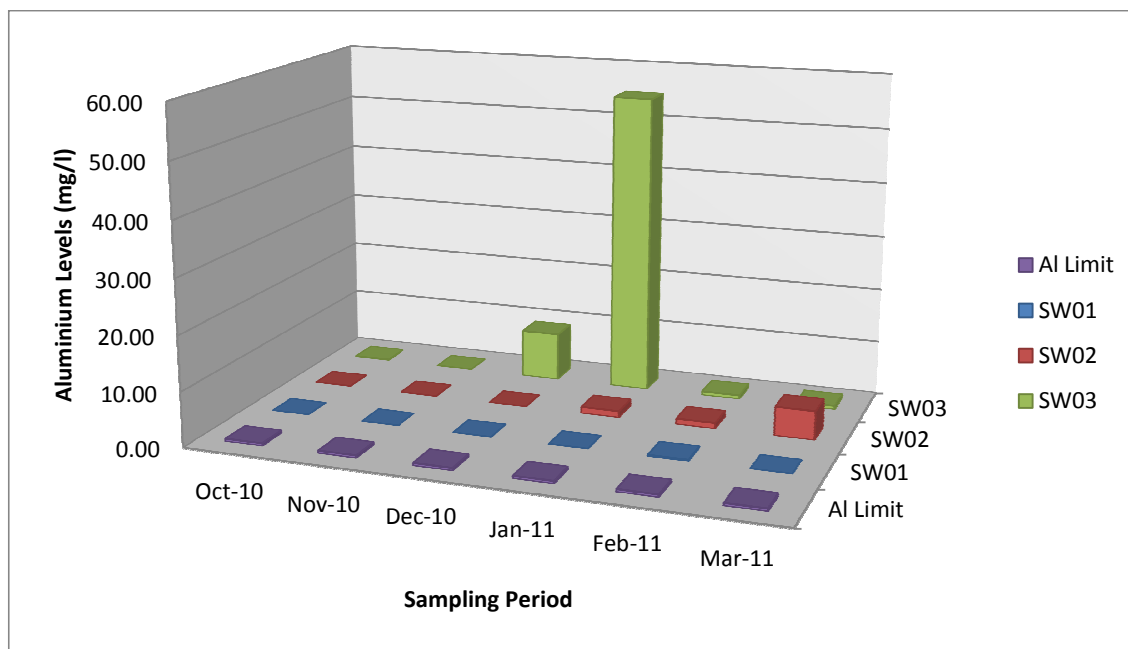
**Figure 4-6: Aluminium levels determined for the different sampling points and time on Bosmontspruit**

Figure 4-6 shows the trend for aluminium on the Bosmontspruit. A 3-D representation was chosen so as to best depict the results. SW02 exhibited non-compliance with the TWQR from January through to March. This is most likely due to the trace elements of aluminium that can be found in silicates which is characteristic of the material stored at the mine waste rock dumps. During January there was a significant increase in aluminium levels at SW03 and this could have resulted from a discharge from the mine storm water pond. No sample was analysed from the mine pond however it was clear that there was discharge from the pond and probably contained high aluminium levels.

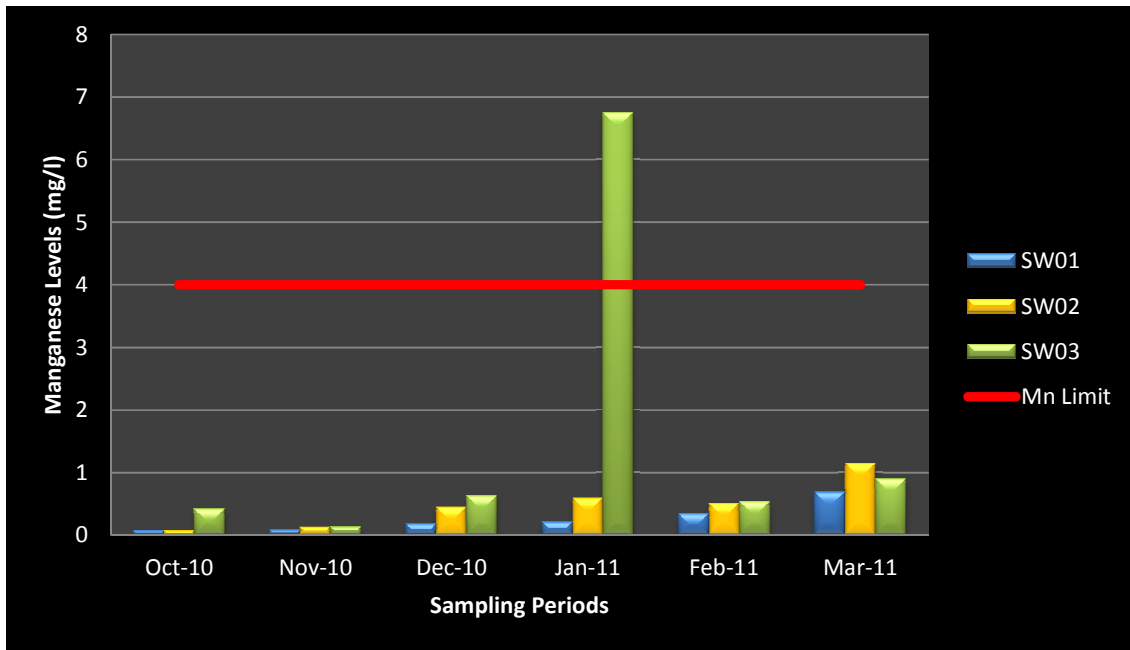
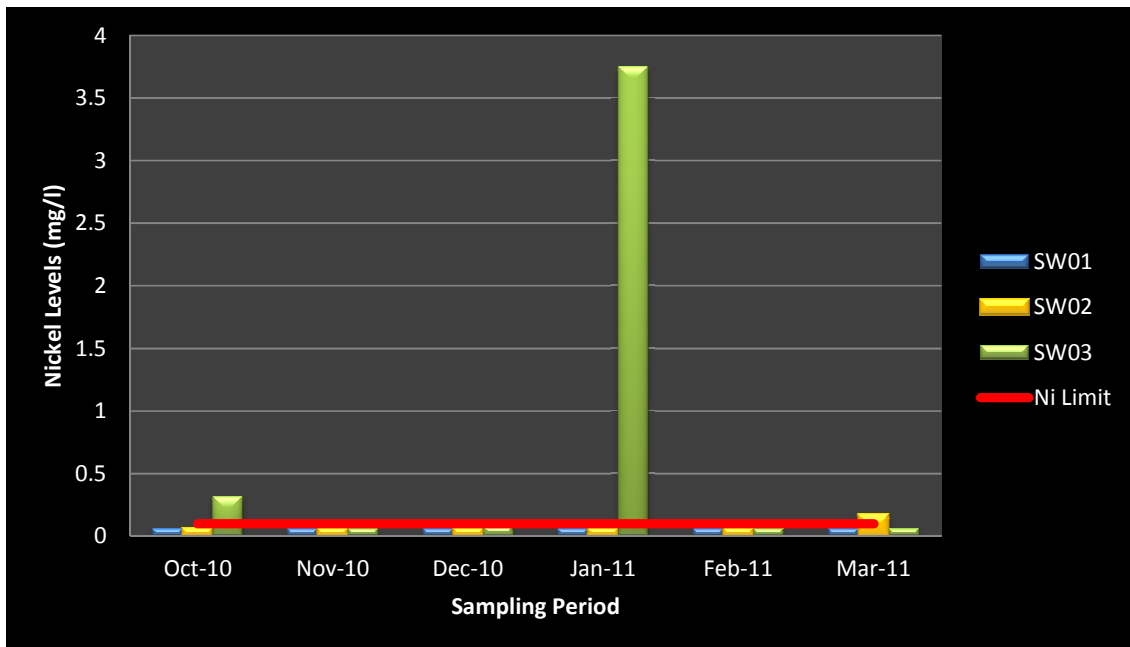
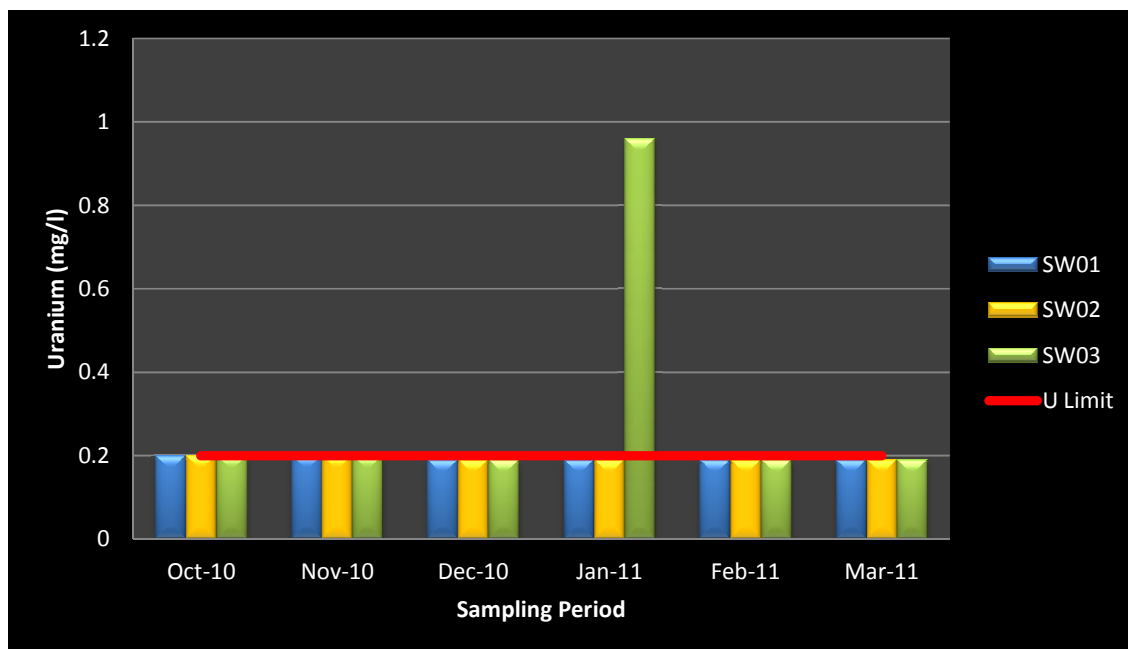
**Figure 4-8: Manganese levels determined for the different sampling points and time on Bosmontspruit**

**Figure 4-9: Nickel levels determined for the different sampling points and time on Bosmontspruit**

**Figure 4-10: Uranium levels determined for the different sampling points and time on Bosmontspruit**

Figure 4-8 through to 4-10 represents the levels of manganese, nickel and uranium on the Bosmontspruit. All of the above metal constituents complied with the TWQR throughout the monitoring period except SW03 in January. These parameters increased in order of magnitude of approximately 10 times during this month.

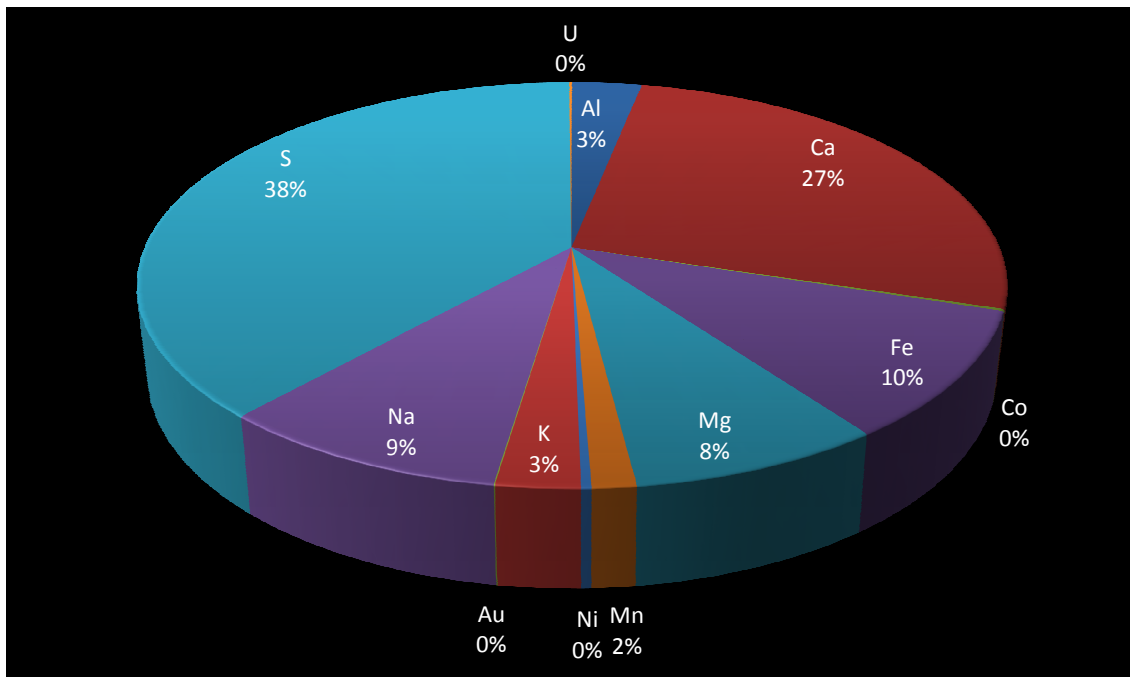
**Figure 4-13: Metal concentrations by proportion in water at SW04 from October 2010 to March 2011**

Figure 4-13 depicts the levels of metal concentration at SW04, as stated earlier the water in the central basin has a dominant elevated calcium, magnesium, sodium and sulphur characteristic. The most noticeable high concentration of metal at SW04 was for iron; with a concentration of 10% of the total metal constituents indicating that there is a potential of iron leaching from the pyrite bearing material contained in the redundant gold waste material.

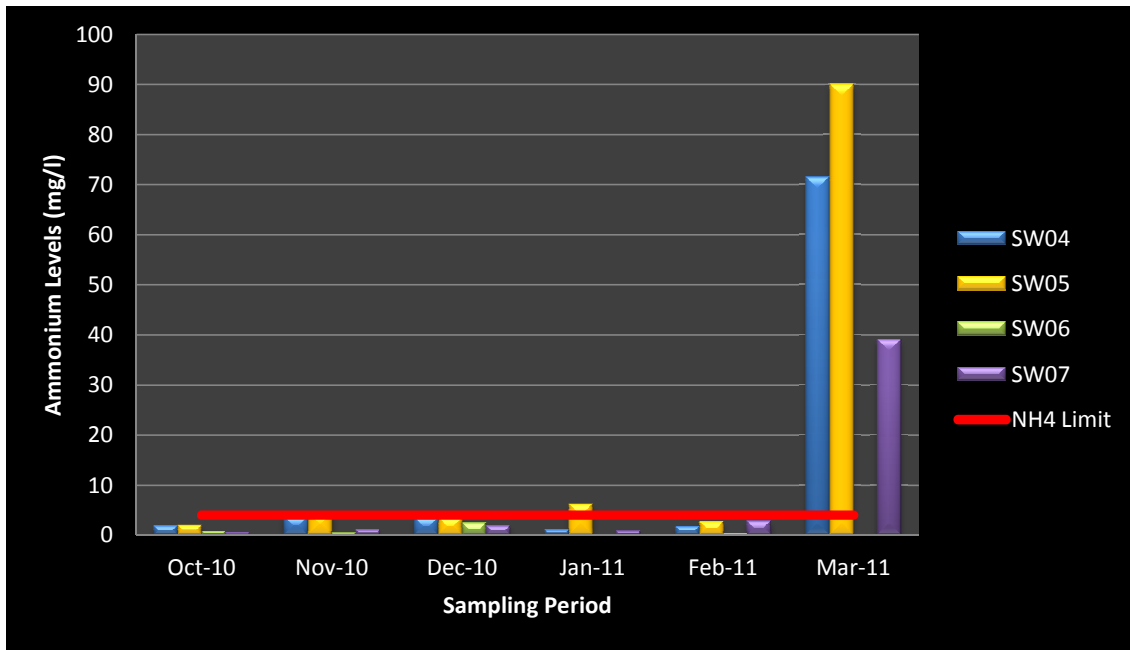
**Figure 4-20: Nitrate levels determined for the different sampling points and time on Russell's Stream**

**Figure 4-21: Ammonium levels determined for the different sampling points and time on Russell's Stream**

**Figure 4-22: Faecal coliform levels determined for the different sampling points and time on Russell's Stream**

Figure 4-20, 4-21 and 4-22 illustrate the nitrate, ammonium and faecal coliform levels on the Russell's Stream. These three parameters are very closely linked. SW04 and SW05 showed elevated nitrate levels in October and November, this coincided with elevated faecal coliform levels for these months. A spike was noted in

the ammonium levels in March in SW04 and SW05. It would be expected that the levels of nitrate, potassium and faecal coliforms fluctuates as the human activities and number of individuals that reside in the area continuously fluctuates. This water is used for domestic purposes by these individuals as well.
