**ENVIRONMENTAL GEOHYDROLOGICAL INVESTIGATION: FOCUSING ON THE
ONDERSTEPOORT LANDFILL SITE, GAUTENG, SOUTH AFRICA**

MASTER OF SCIENCE IN ENVIRONMENTAL MANAGEMENT

UNIVERSITY OF SOUTH AFRICA

NOVEMBER 2022

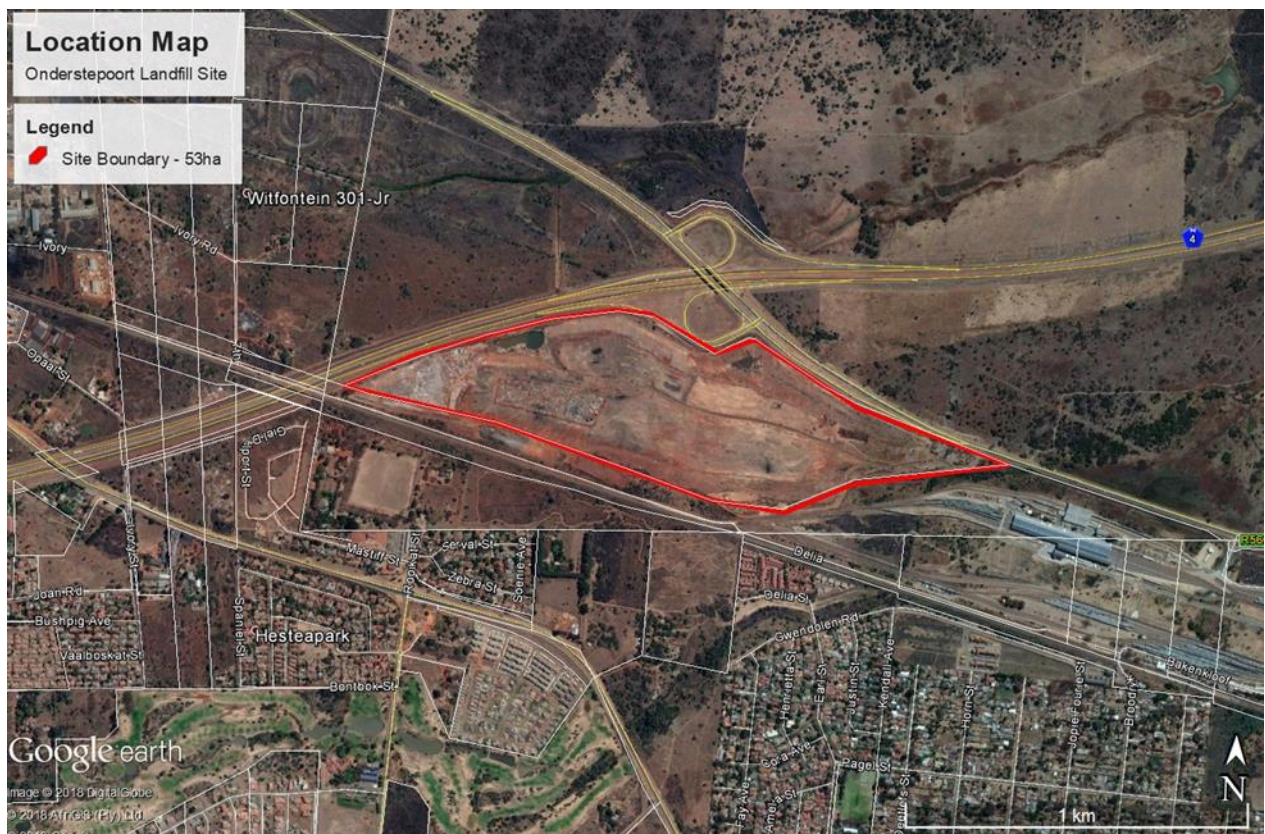
Figure 3. 2: Onderstepoort landfill facility (LEAP, 2019).

According to Tshibalo (2017), the facility has no operational weighbridges to measure quantities of waste disposed of on-site and there is no bottom liner on the site to prevent groundwater pollution. The proposed study area is about 53 hectares in size (Figure 3.2). The site reached its 20 years lifespan and is in the process of being officially closed (LEAP, 2019).

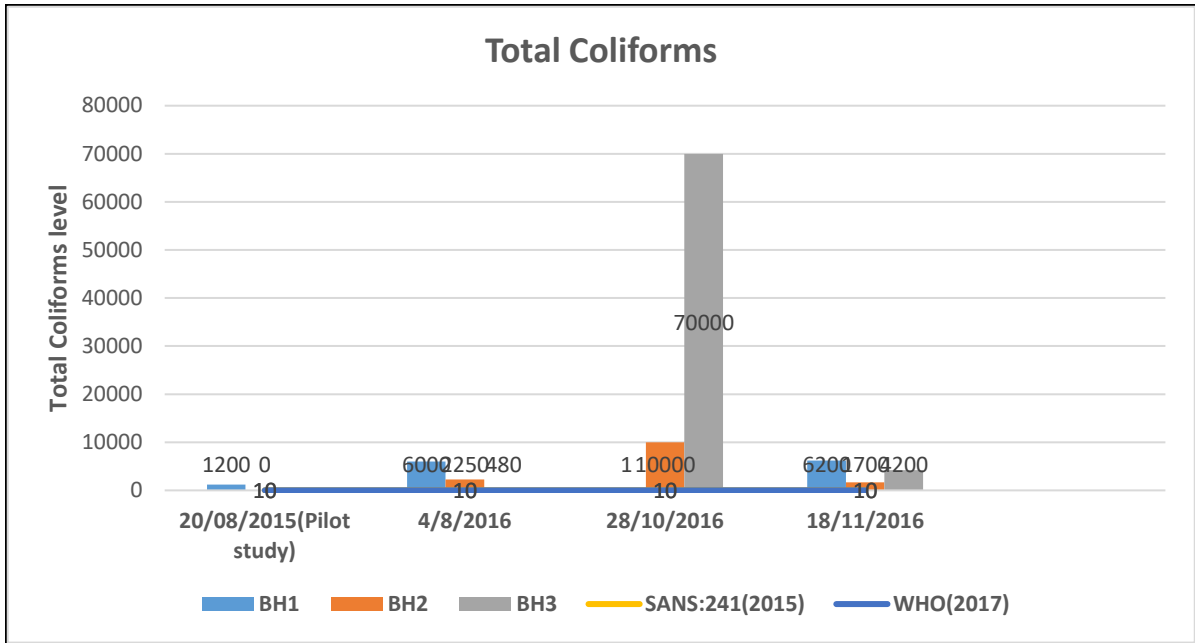
Figure 4.7: Total Coliform concentrations in water samples collected from BH1-BH3 sampling sites

Borehole 03, 01 levels were measured between 4000 – 4200. The lowest level of Total Coliforms was measured in borehole 01 and borehole 03 on 28 October and 04 August 2016. The concentration level of Total Coliforms was high than acceptable limits as compared to SANS 241: 2015 and WHO (2017) water quality standards.

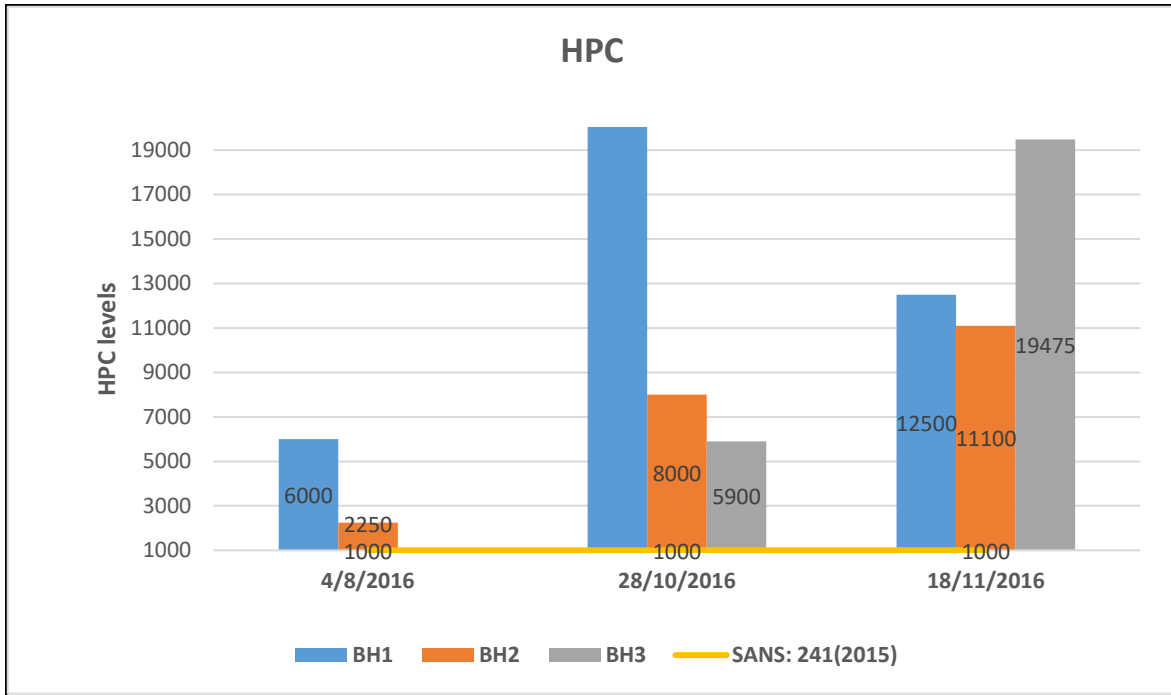
Figure 4.8: Heterotrophic Plate Count concentrations in water samples collected from BH1, BH2 and BH3 sampling sites.

Borehole 03 measured 19475 on 18 November 2016. The lowest level was 480 measured in borehole 03 on 04 August 2016. The HPC level was higher than acceptable limits as compared to SANS 241: 2015 and WHO (2017) water quality standards levels were not specified.

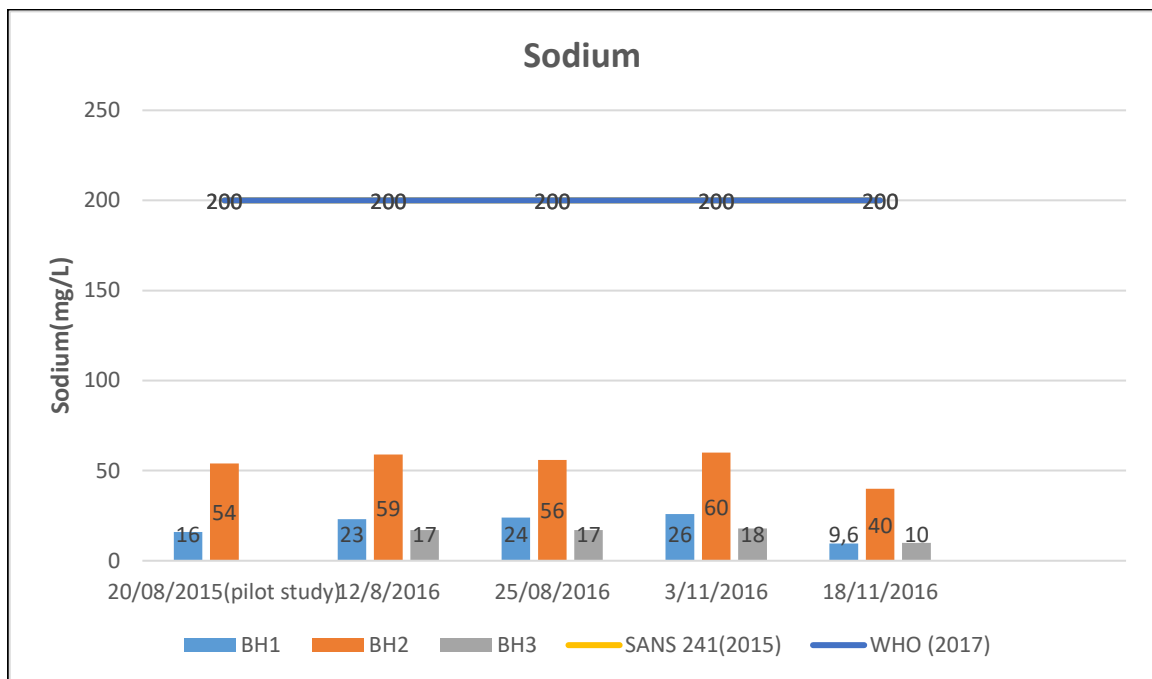
Figure 4.18: Sodium concentrations in water samples collected from BH1, BH2 and BH3 sampling sites.

within acceptable limits when compared to SANS 241: 2015 and WHO (2017) drinking water quality standards.
